# *Acutec Home Inspection*

## Property Inspection Report

Sample ave, Sacramento CA, 95888  
Inspection prepared for: Sample Sample  
Agent: sample sample -

Inspection Date: 10/27/2011 Time: 11:00 am  
Age: 54 years built 1957 Size: 2233 Sqft.  
Weather: Clear

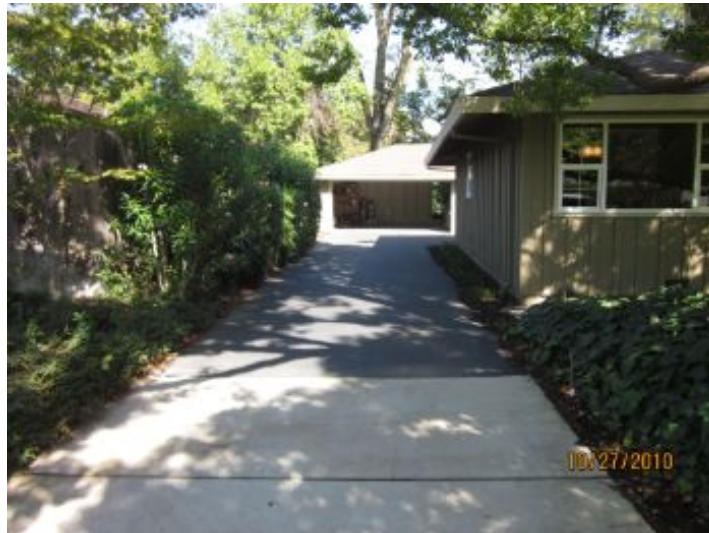
• Asphalt has some normal cracking. Recommend filling the cracks and sealing the asphalt to extend its serviceable life. Concrete light cracks normal.

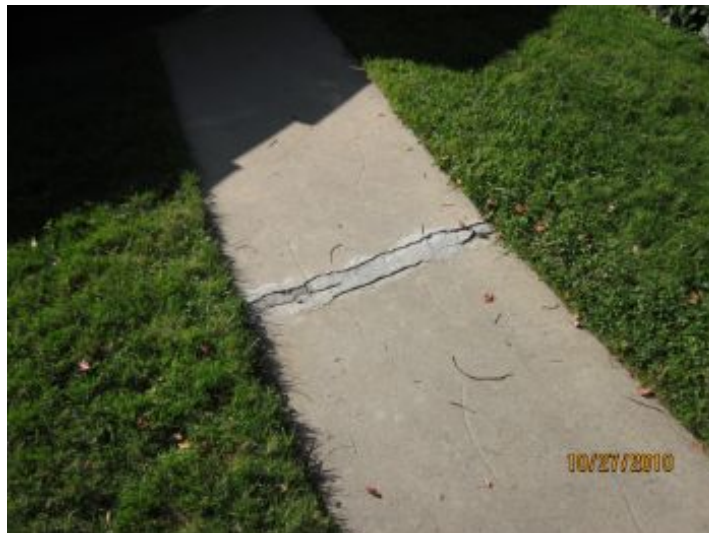
- A crack in the walkway leading from the street has a repair that will need to be re-done in the near future. It was done to smooth out a tripping hazard. The concrete used to do the repair is coming apart. [Repair as needed.]

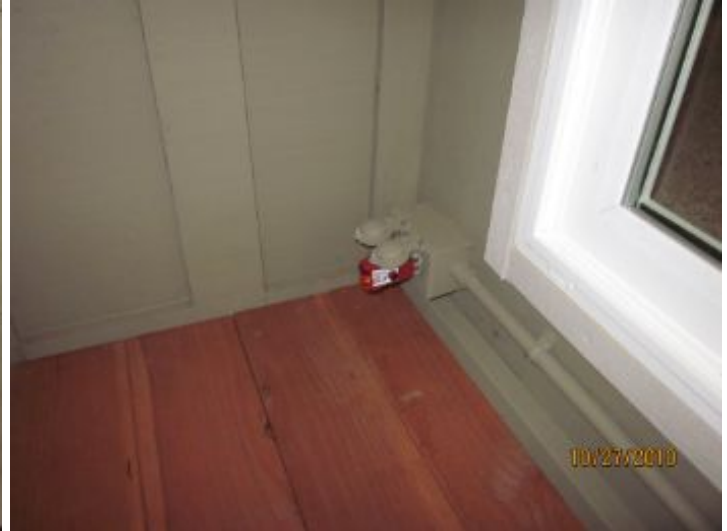
At patio

• *Outside outlets have an open ground and are not GFCI protected. GFCI outlets have been required since 1973 on outdoor outlets. Consider upgrading to the current safety standards of GFCI protection.*

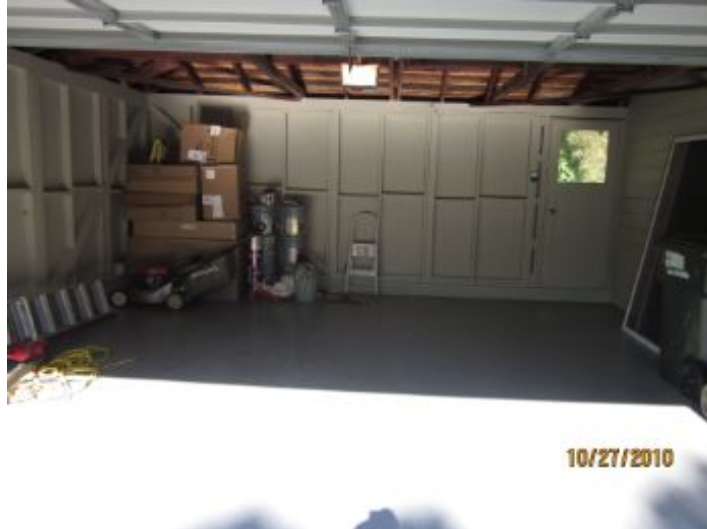
- Common cracks noted.

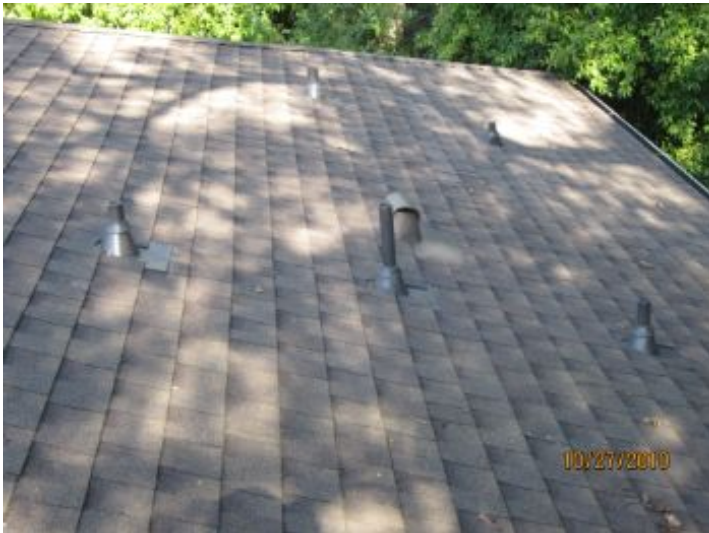
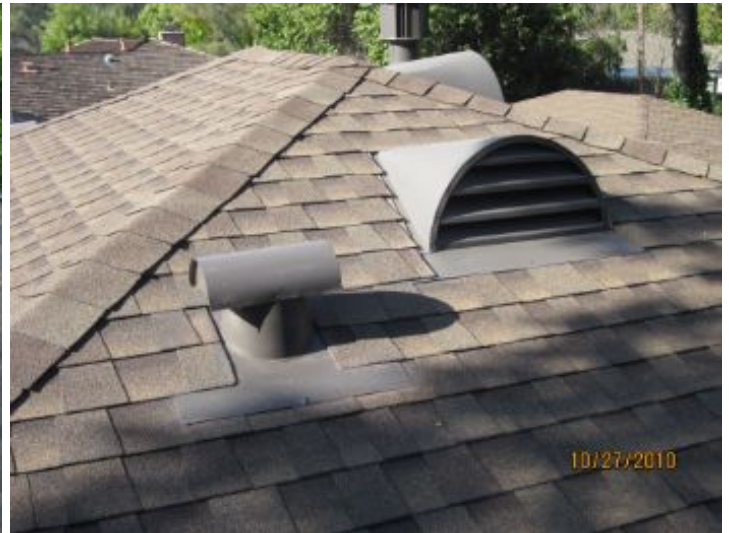
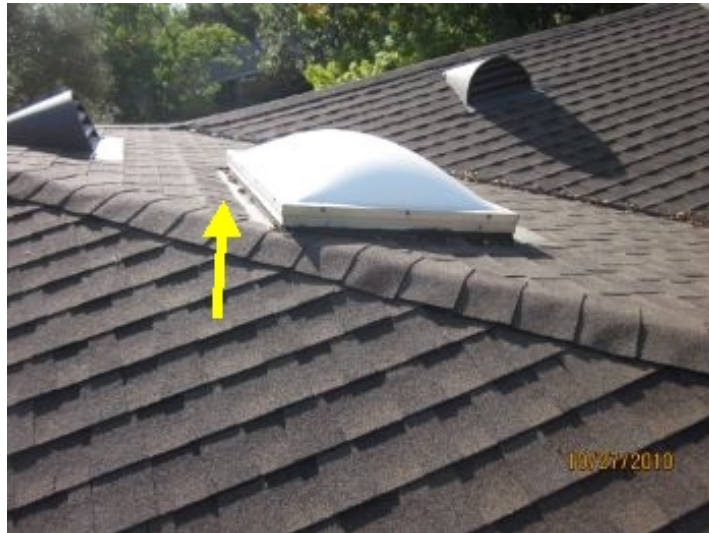
Keep clear of debris

- Keep the flashings around the skylight and chimney clear of leafs/debris. Clean at time of inspection. "Maintenance"
- No discrepancies.

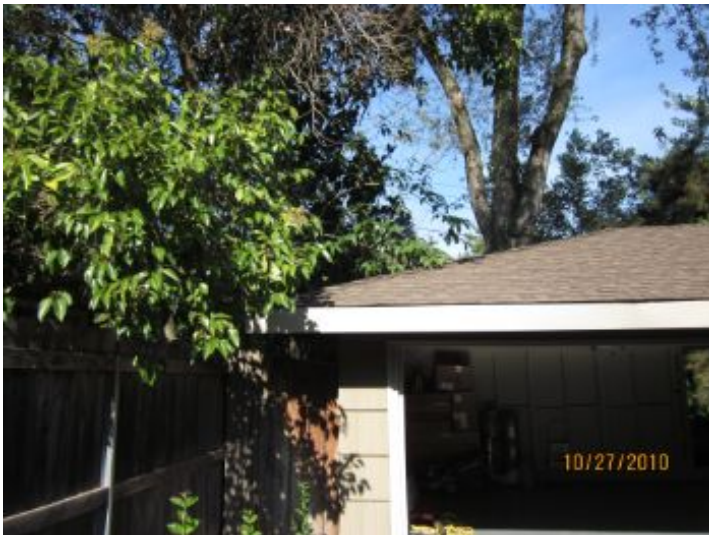
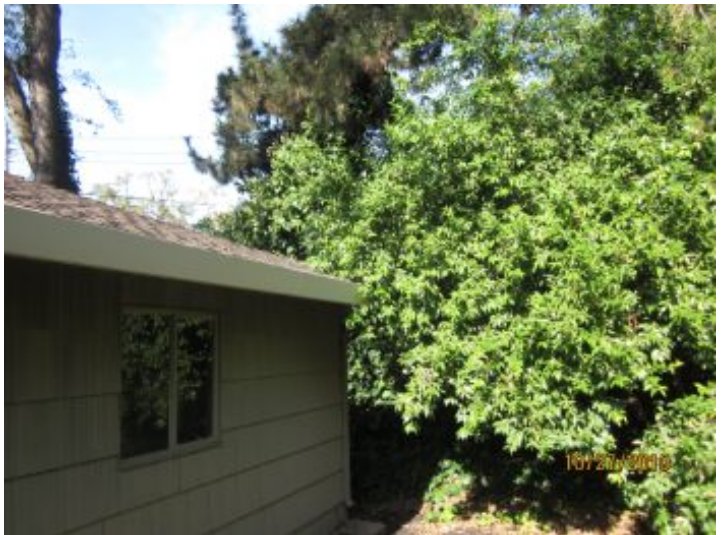
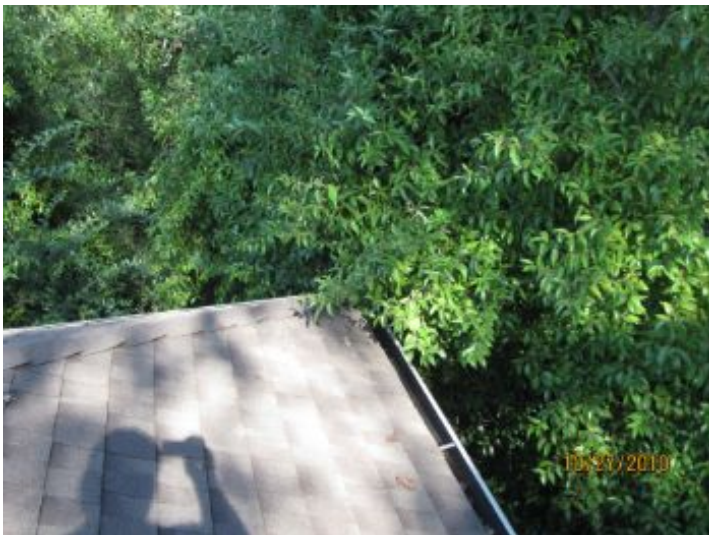
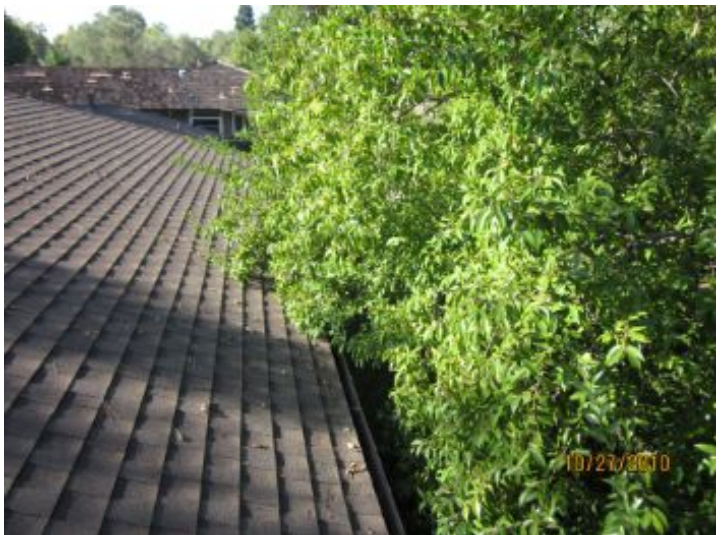
- Trees are over and touching the roof in several locations. Trim back away from roof.  
[Maintenance]

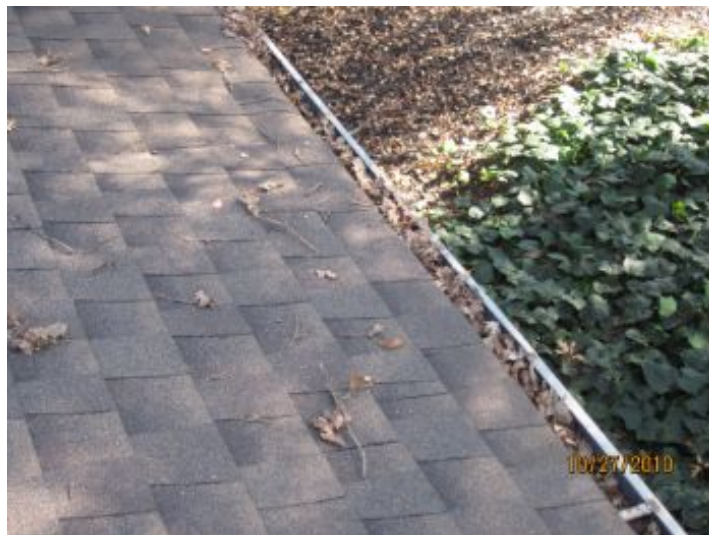
- Gutters need to be cleaned and maintained to allow for proper drainage.
- Gutters have been repaired at the corners. May need future maintenance.

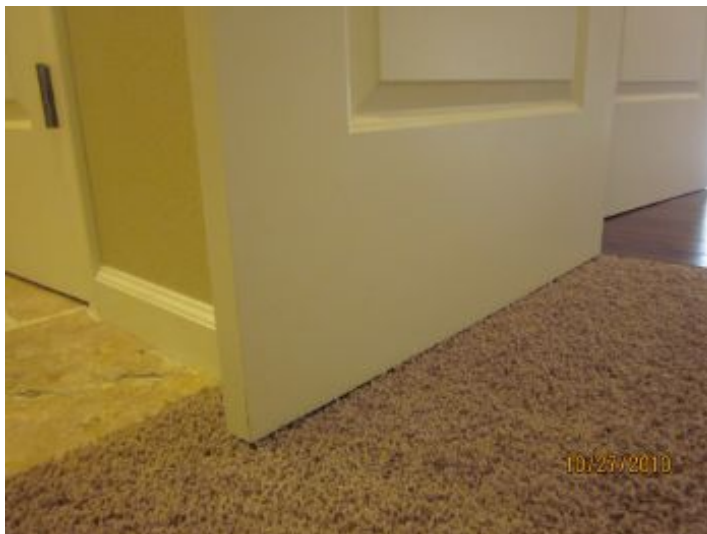
- *Bedroom doors should have 1/2 to 3/4 " clearance above carpet for adequate air flow. When doors are closed and heat or air conditioning is running the gap under the door is needed to equalize the pressure. Note: If doors are left open there is no issue. [Repair as Needed]*

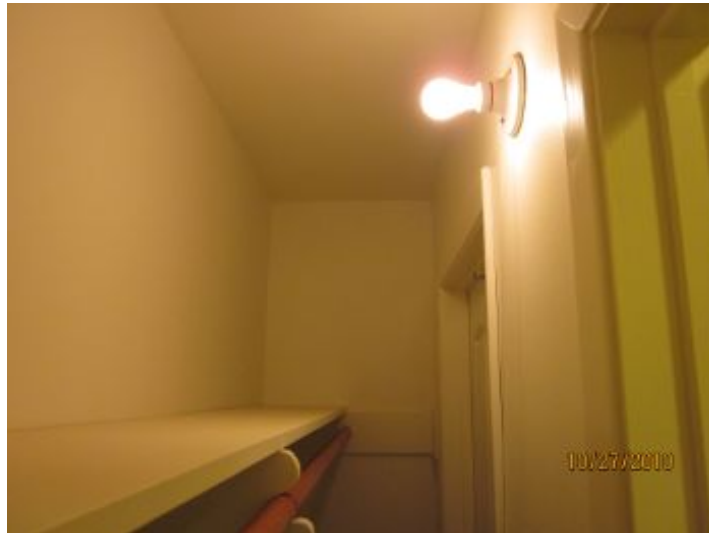
master closet in M-bath

- *Closet in master bathroom has an incandescent light with only 5" of clearance from edge of shelf. This is a fire hazard as combustible items stacked on the shelf could come into contact with light bulb. [Repair as Needed] [Safety]*

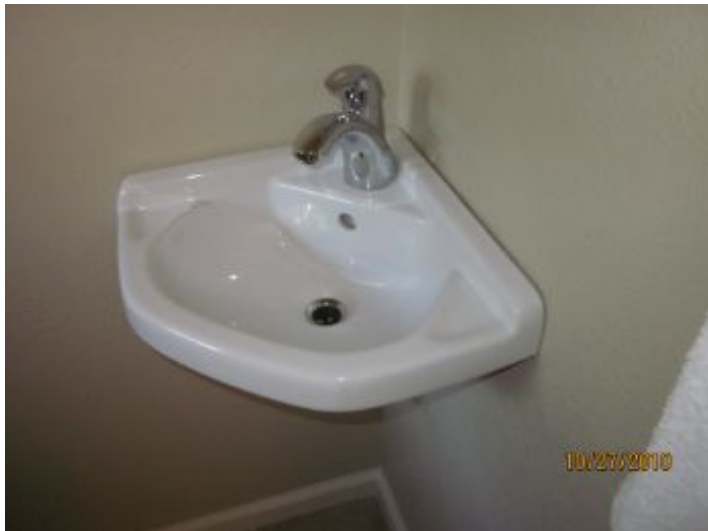
- *Sink in 1/2bath is not securely fastened to wall. {repair as needed}*

1/2 bath sink not secure.

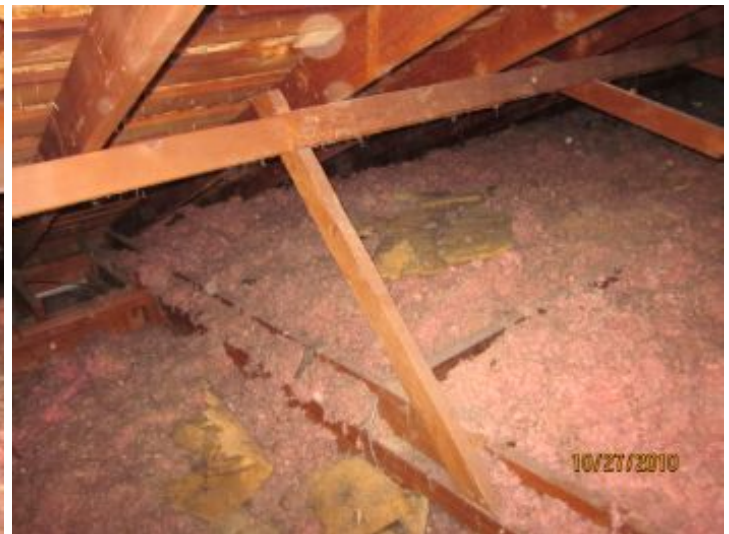
- *You may benefit from upgrading the attic insulation.*

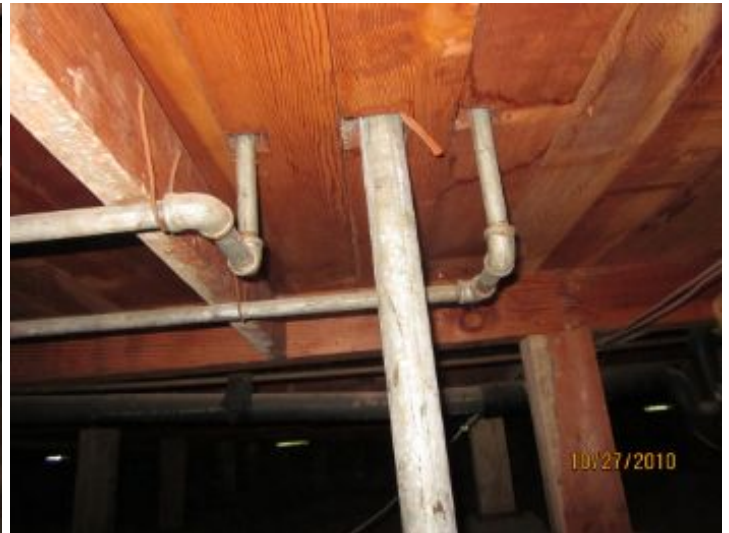
Pex to Galvanized

- Pex piping has been installed and ran approximately half way to where it has been attached to original galvanized piping. It appears that the pex only runs fully to bath 2.
- Drain pipe leak in crawl space under kitchen. Very slow drip at iron pipe joint see photos. [Repair as needed]

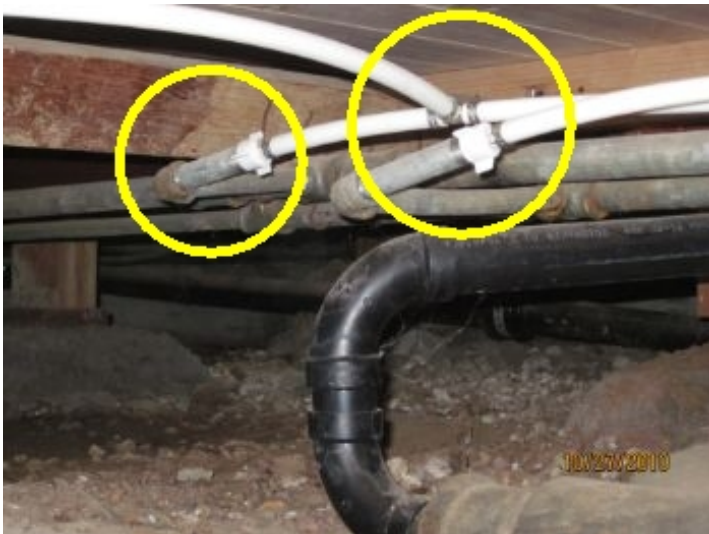
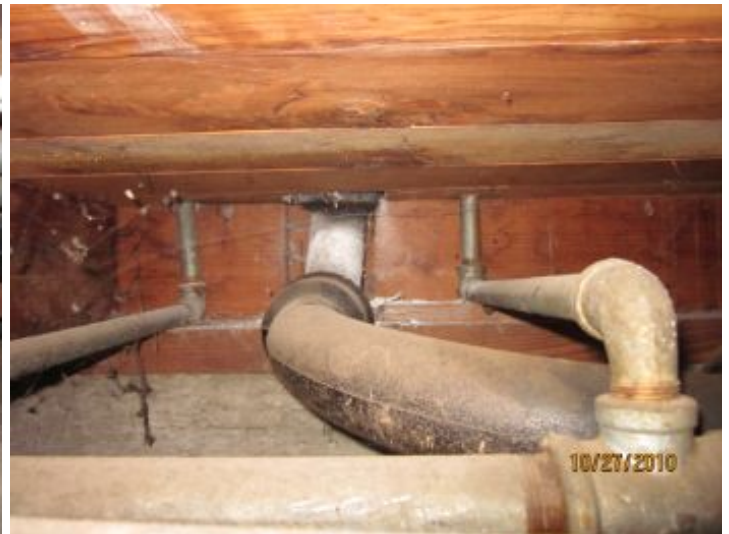
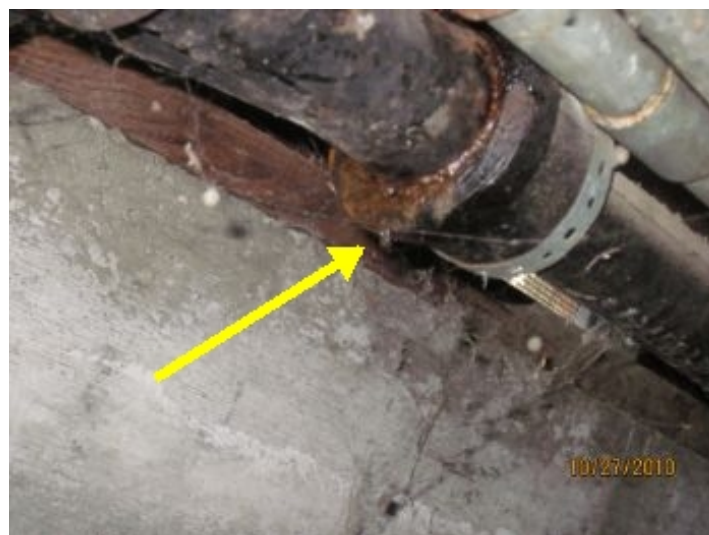
Leaking slowly under kitchen

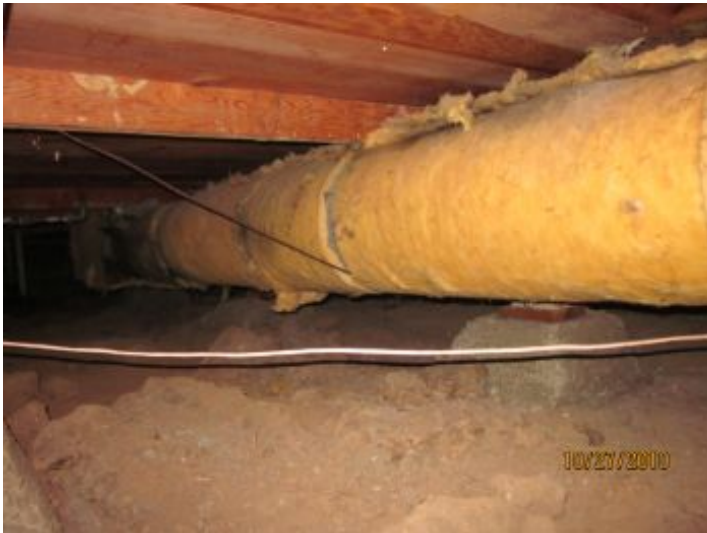
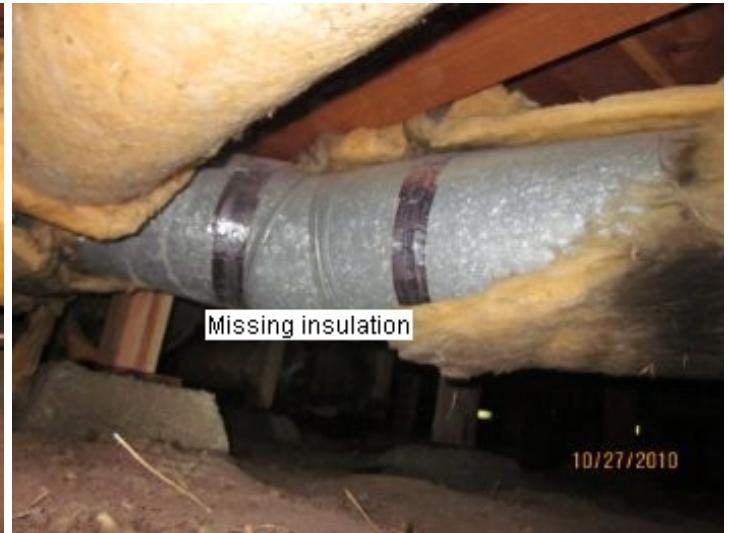
- Galvanized ductwork has approximately 6' section of insulation missing. [Repair as Needed]

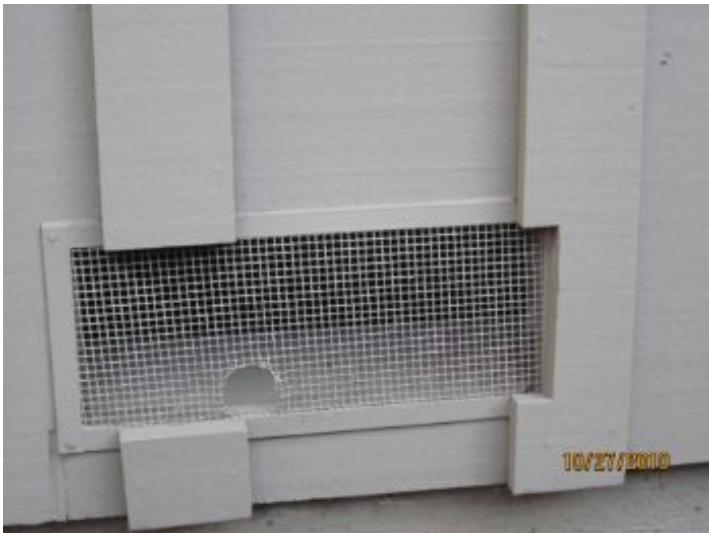
Repair hole in screen left side of house.
