Acutec Home Inspection

Property Inspection Report

Sample, Sample City, CA 95757
Inspection prepared for: Sample Sample
Real Estate Agent: Gus verras - Test co

Date of Inspection: 9/10/2012 Time: 3pm
Age of Home: 8 yrs Size: 3,753 sq ft
Weather: clear

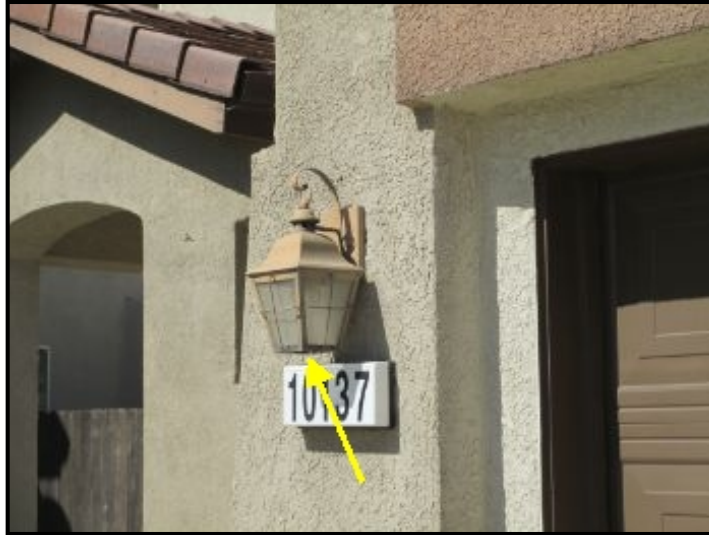
- "SAFETY CONCERN"
- One hornet, or wasp nest was found. These can pose a safety hazard. Nest(s) should be removed as necessary.
- Wasp nest inside of exterior light fixture.

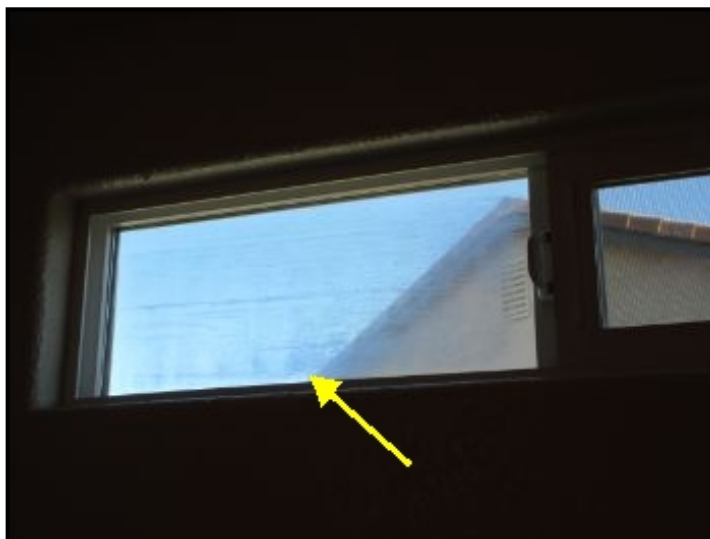
Bath 2

- Bath 2; 1040 fixed window has a lowe E failure. This is not a concern with moisture or a failure of the seals. It is a failure of the lowe E coating between the panes of glass. You may want to replace it for ascetic reasons.

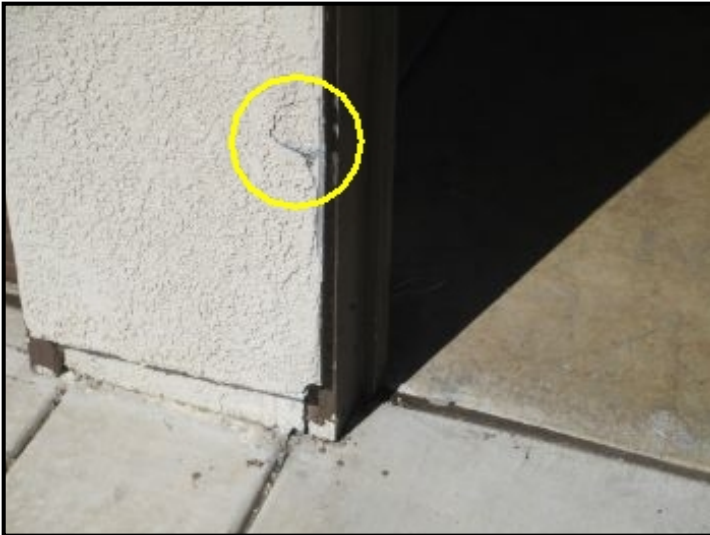
- Stucco Cracks. It is the nature of stucco to experience some cracking. The cracking I observed here was a little more than normal. The concrete footings below show no signs of failure which leave settling of the structure as the cause. When a crack exceeds 1/8 inch in width then the crack should be repaired. Repairing of stucco cracks is made by adding a small amount of stucco to the crack. Stucco caulking can also be used. "FYI" From the california building guidelines set forth in SB 800.

Minor stucco damage

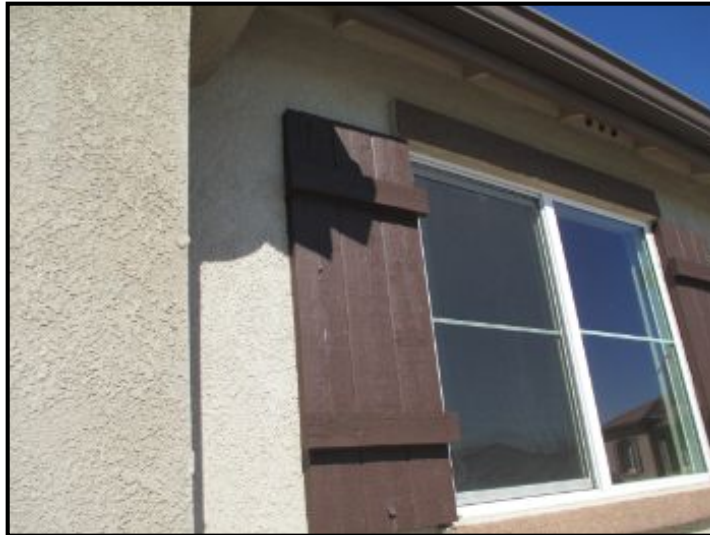
- "INSPECTED"
- Exterior trim appears to be in good condition wear consistent with age.
- "MAINTENANCE"
- As a preventative maintenance measure we recommend caulking/sealing all voids between siding, trim, windows and gaps to avoid the possibility of water intrusion.

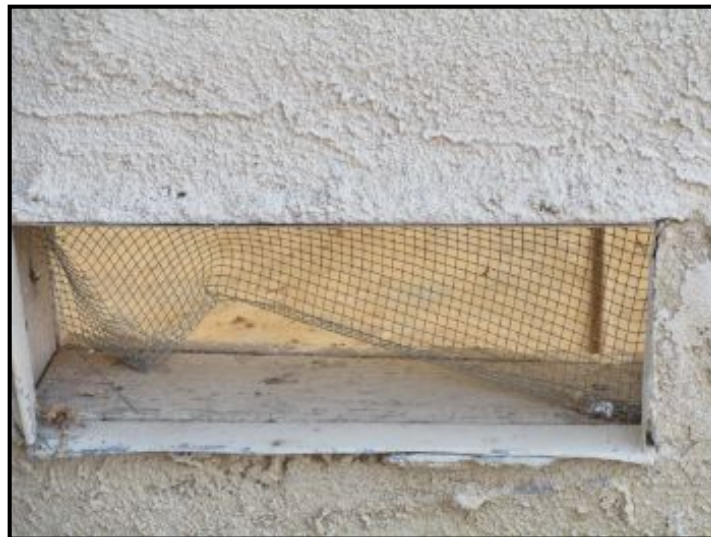
- (1) vent screen damaged."Repair as needed"

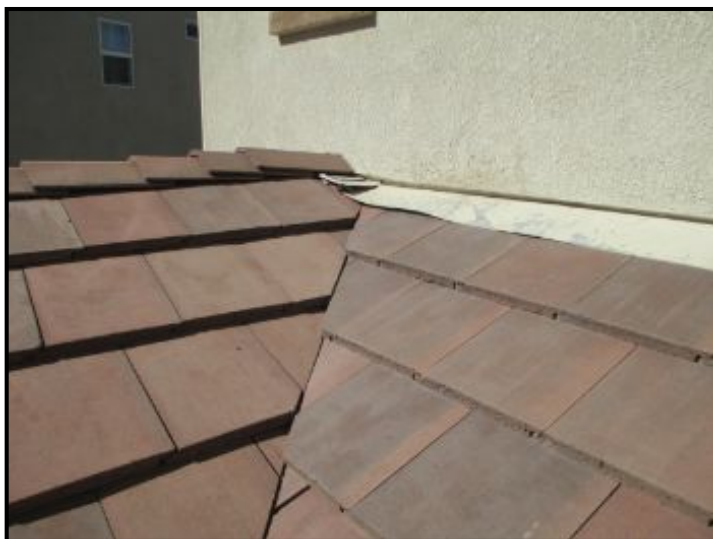
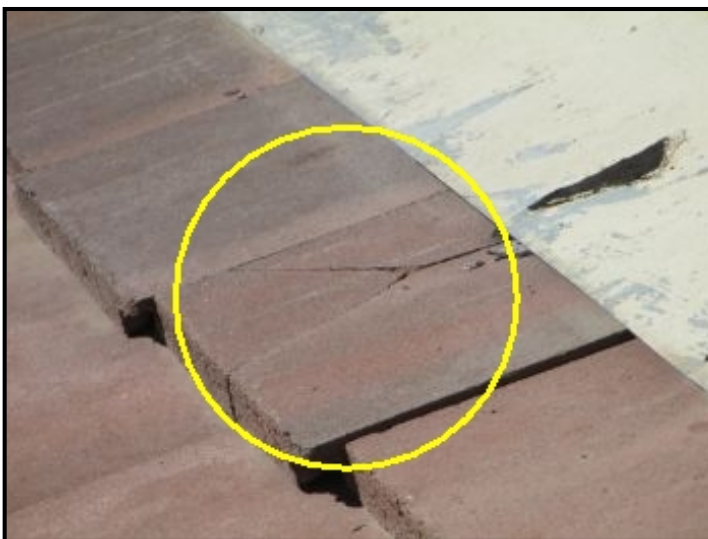
- (1) broken tile at front lower level. Can be repaired or replaced.

Damaged tile front of house

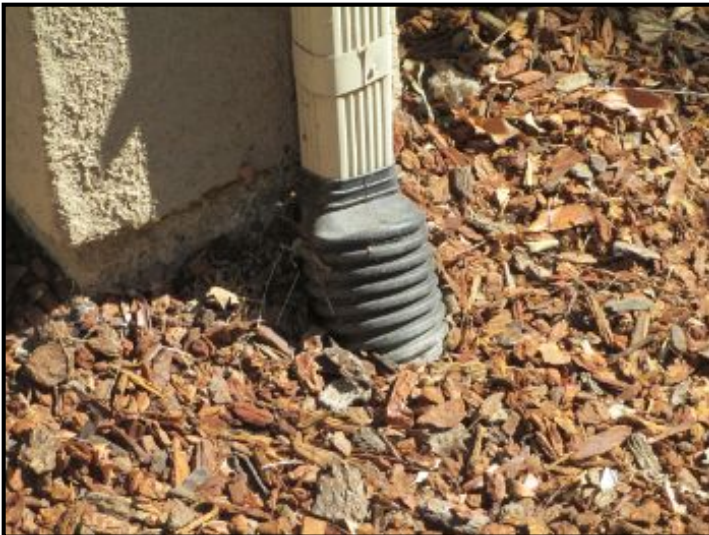
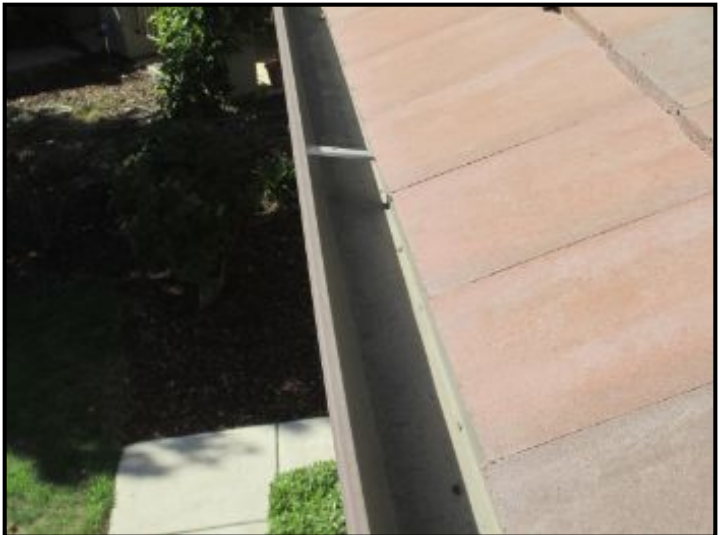
- Most downspouts hooked to underground drainage. Underground drainage is beyond the scope of this inspection.

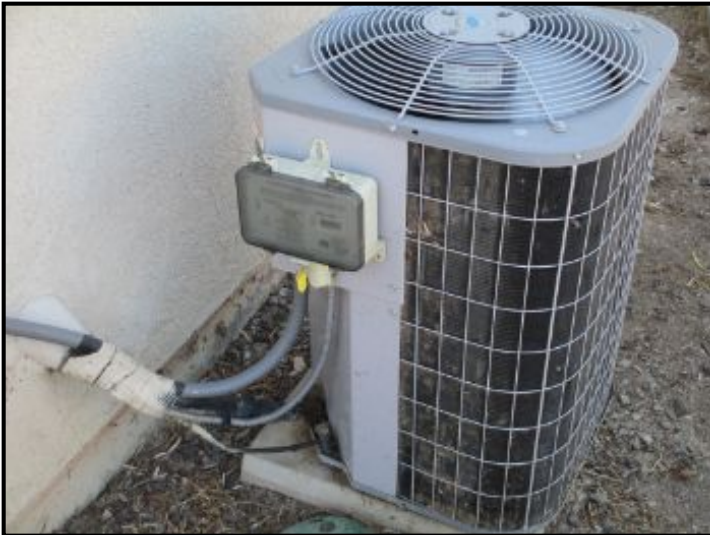
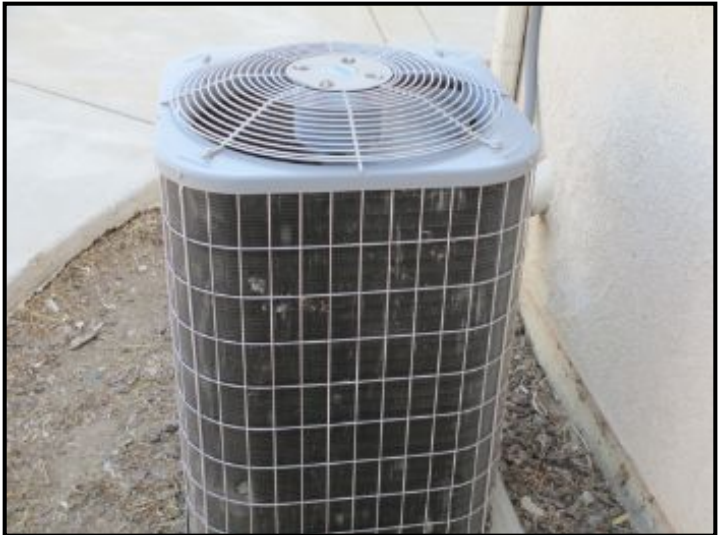
- The unit functioned correctly using the normal controls (Thermostat).
- The typical temperature differential split between supply and return air in an air conditioner of this type is 15 - 20 degrees F. This system responded and achieved an acceptable differential temperature of 16 degrees F.
- "MAINTENANCE"
- The exterior condensor is dirty and needs to be cleaned.

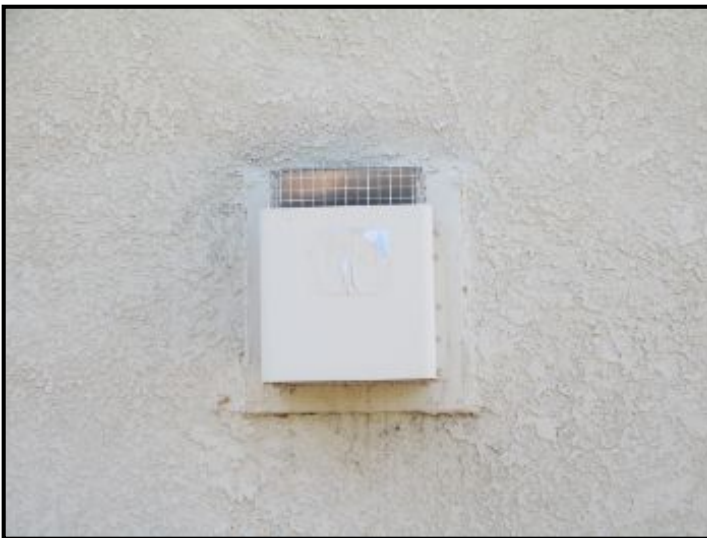
Direct vent

- The top panel is missing a few of the Louvre vents, and needs to be replace.
- The unit would not stay lite. It would start for a few seconds and then turn off. The usual cause of this is a worn or misaligned thermal coupler. recommend having unit serviced by a certified technician.

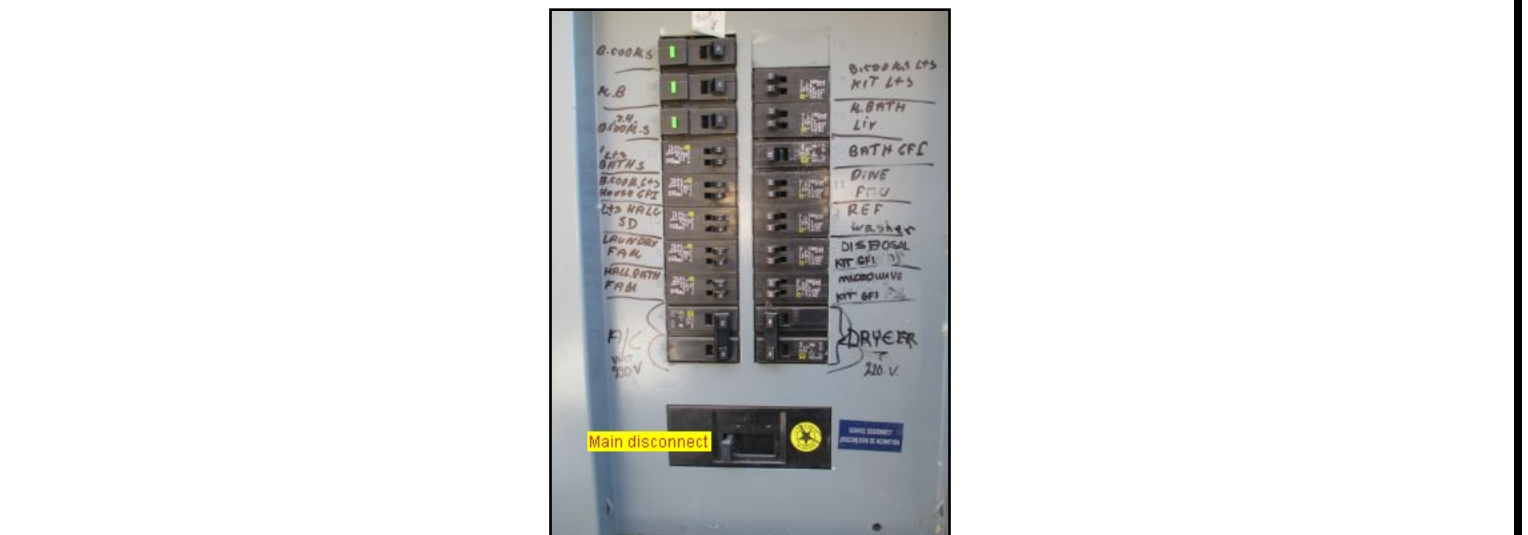
Inspect	Not Inspect	Not Presnt	Repair Replac	FYI	
X					Description: Square D Panel Location: Right side Of House Observations: • No major safety or function concerns noted at time of inspection at main panel box.

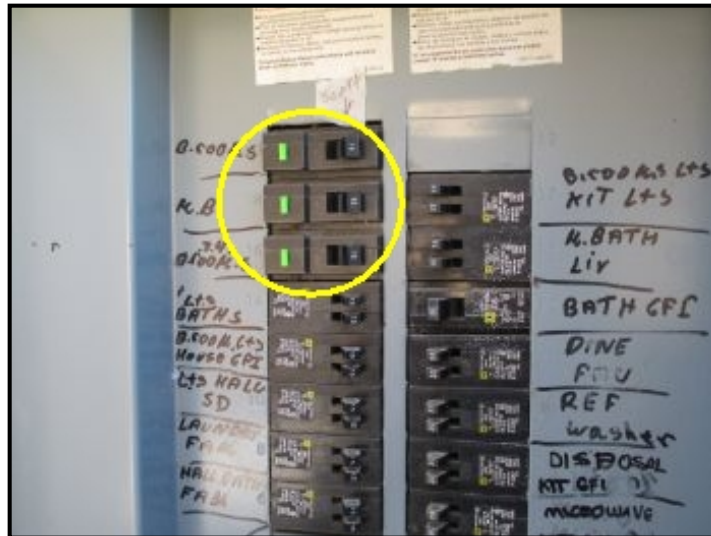
Observations: Arc fault breakers in place and operational. recommend testing monthly by pushing the test button on the breaker and then resetting.

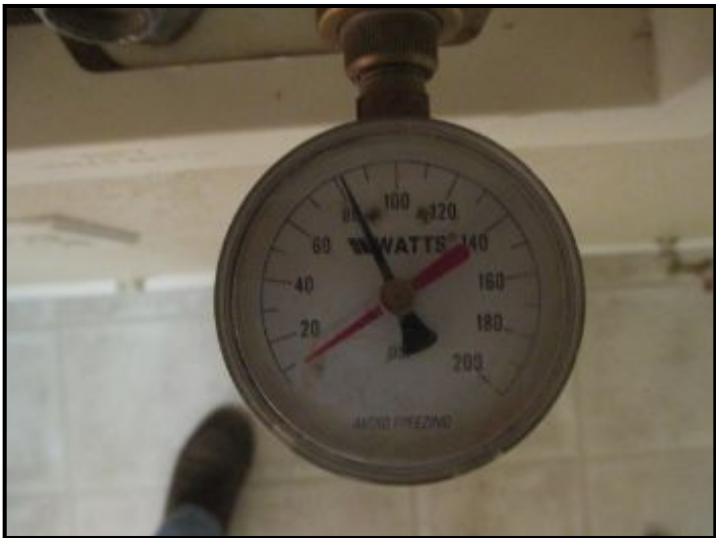
Observations:
• 80 psi
• Normal Range is 40 - 80 psi (GOOD)

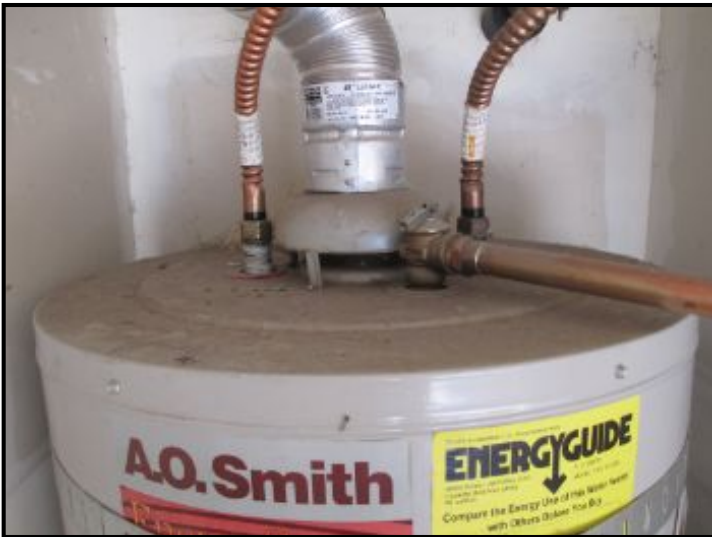
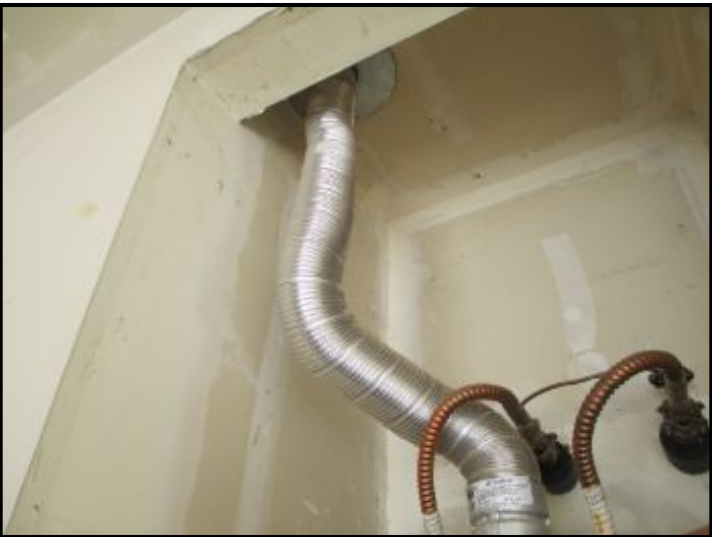
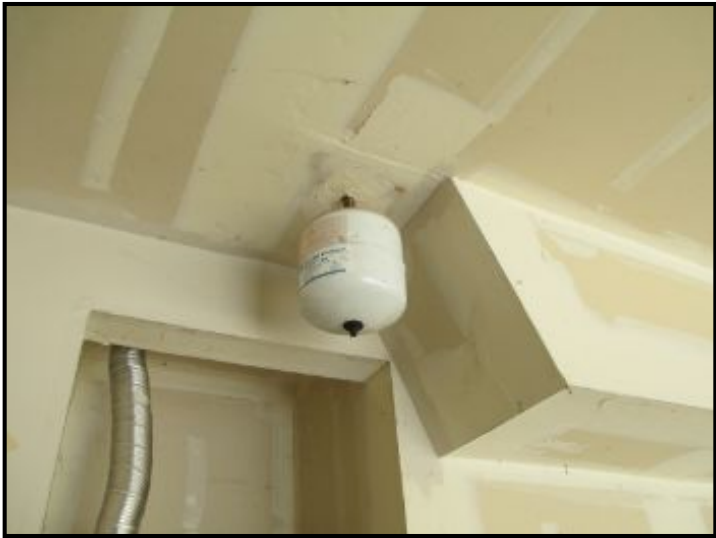
Observations:
• Base, Tank Pressure Release Valve, Strapping, Vent, and expansion tank in place.
Inspected no discrepancies.

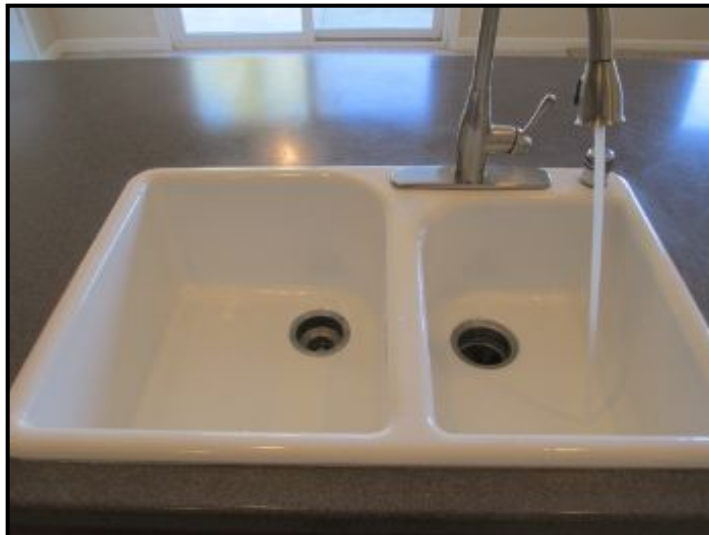
- Kitchen has a Cast iron sink/top mounted.
- Sink appears to have been refinished, suggest taking care when cleaning to protect the surface. "FYI"

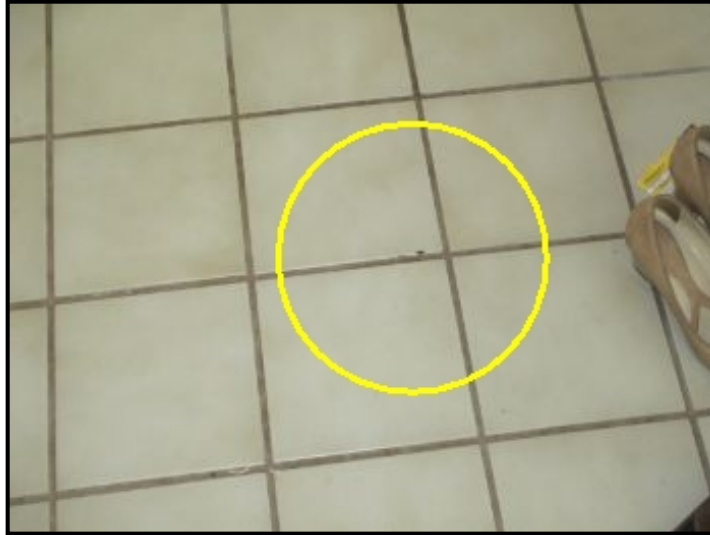
- Tile at entry has normal wear for age, and a few small chips. recommend cleaning grout and sealing.
- Carpet appears to be new no discrepancies noted.

Entry tile

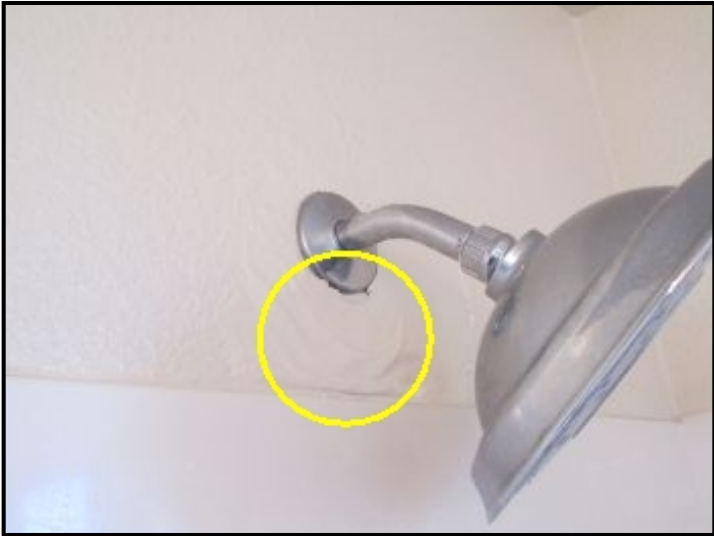
- Materials:
- Textured dry wall Throughout.
- Observations:
- The paint is peeling under the shower head in the master bath. There does not appear to be wall damage. Recommend re painting.
 - "FYI"
 - No other major concerns, some visible patches at loft ceiling.

Paint peeling under shower head, M bath

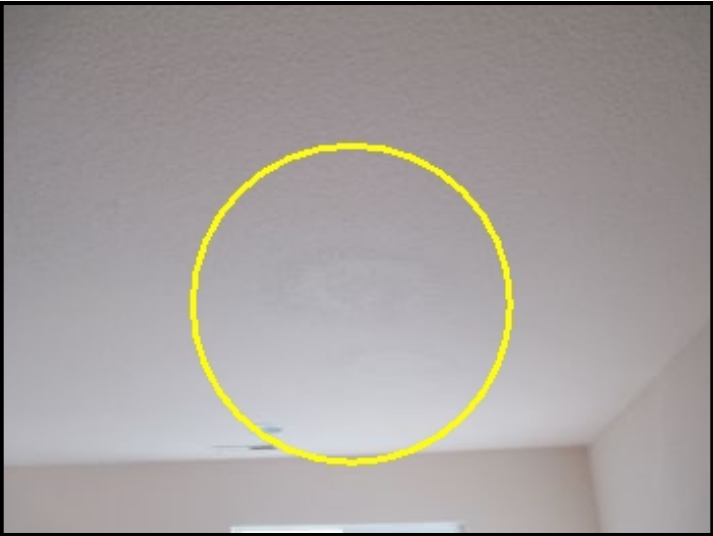
Visible repairs at loft ceiling

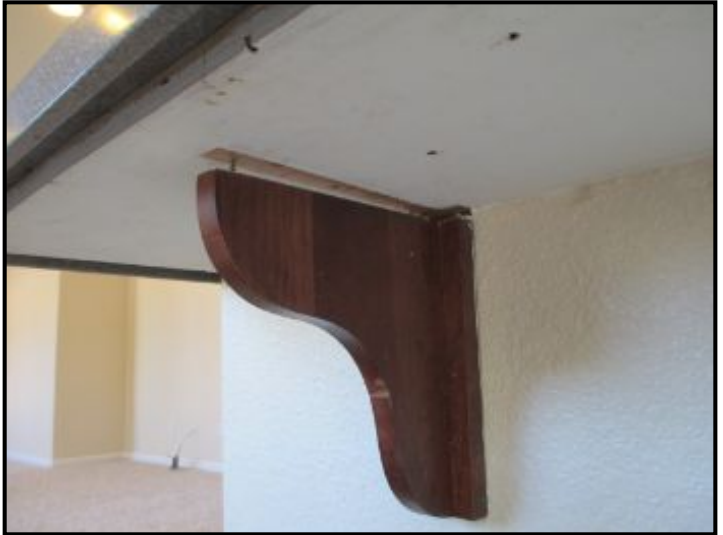
- (1) Broken / damaged drawer guides noted. "Repair/replace as needed"
- Loose corbel under island.

Loose corbel kitchen island

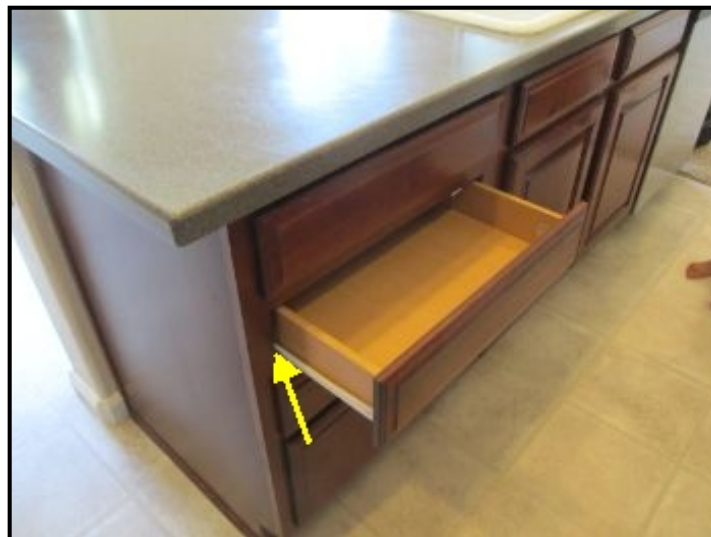
Repair door guide

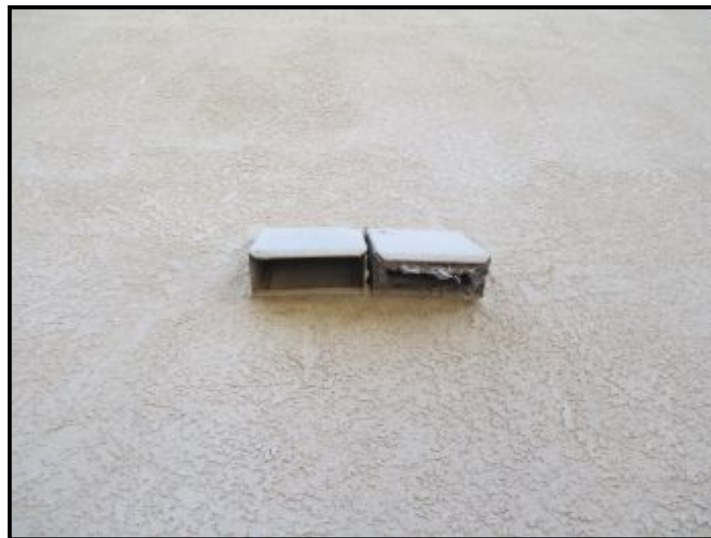
- "maintenance"
- Recommend cleaning dryer vent before use. "Maintenance"

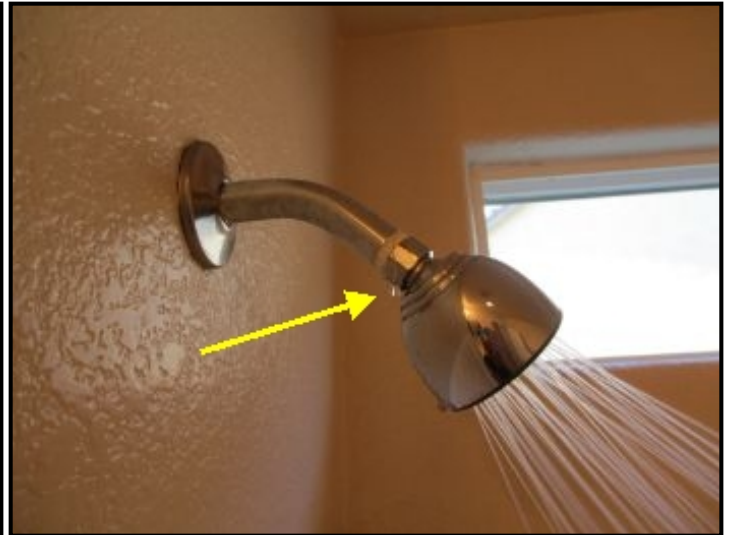
Shower head leaks at connection, Bath 3

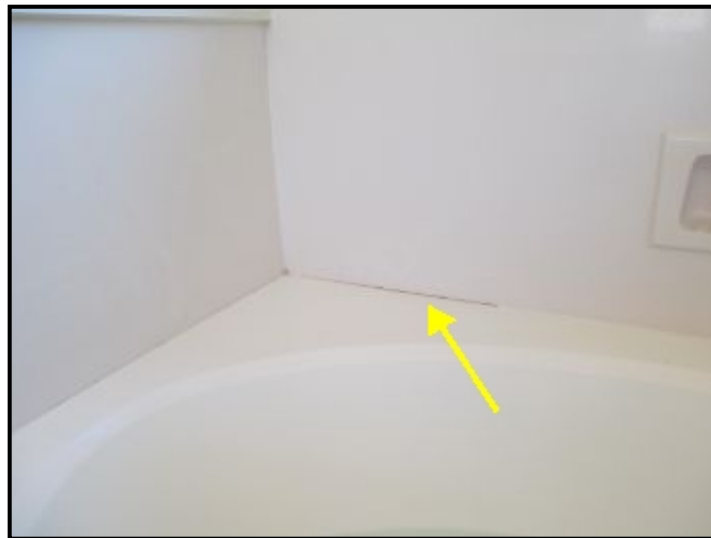
M bath

- "MAINTENANCE" Caulk the tub to surrounds as needed to prevent moisture intrusion at the master bath tub.
- "FYI"
- Both tubs in bath 2 and 3 have a few chips, cosmetic in nature. Can be repaired with touch up products sold at home stores.

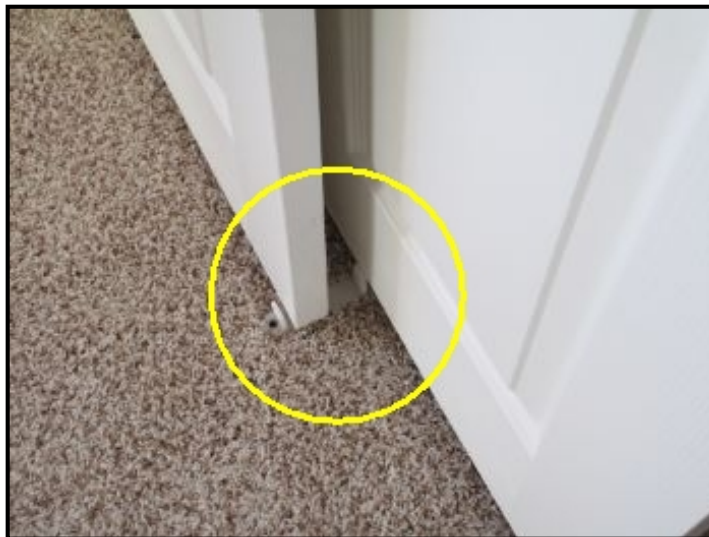
Bed 3

- Bedroom 3 closet: Closet bypass guides is to low and the doors can come loose. Adjust as needed.
