Acutec Home Inspection

Property Inspection Report

1234 Any Street, Sacramento, CA 95624
Inspection prepared for: Renee & James Sample
Real Estate Agent: Gus verras - Test co

Date of Inspection: 9/11/2012 Time: 1pm
Age of Home: 11 yrs Size: 2,830 sq ft
Weather: clear
Includes pool

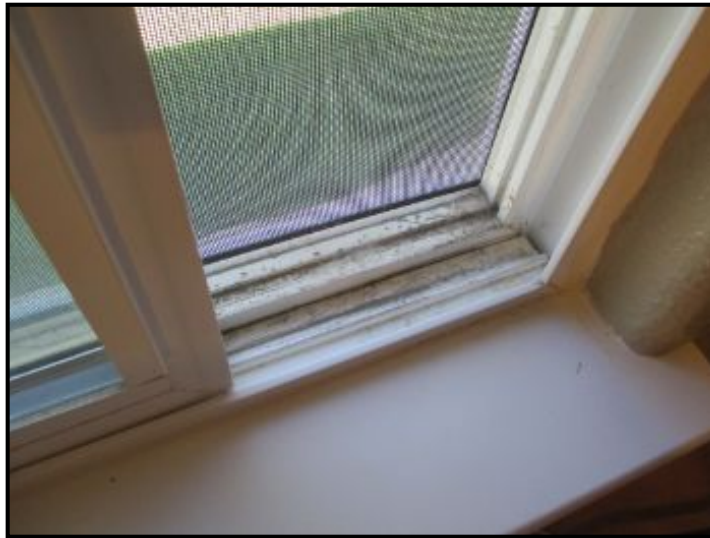
- "MAINTENANCE"
- Recommend cleaning the window tracks and lubricating with a silicone based spray for this purpose. "Maintenance"

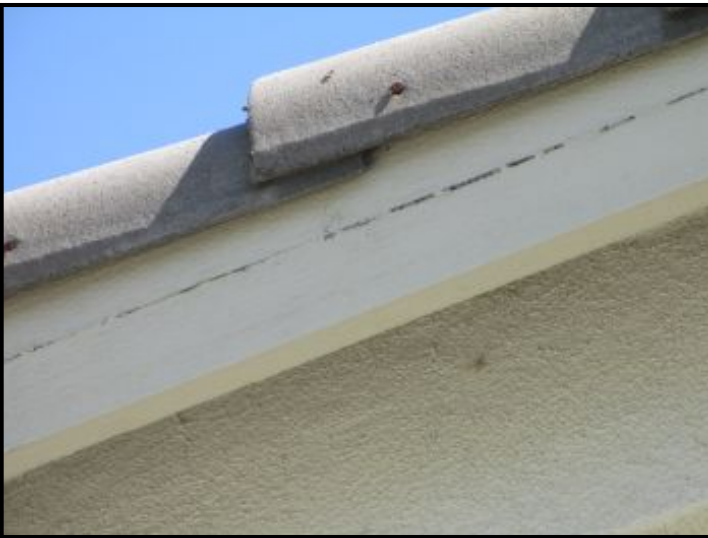
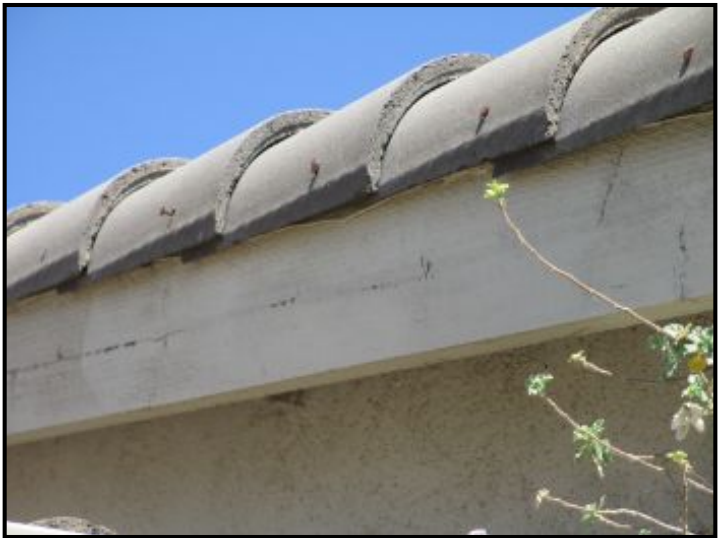
- Peeling paint at facia observed, suggest scraping, prep and paint as necessary.

- Paint is generally in good condition on body of house. The previously mentioned fascia is just starting to peel and crack in the more exposed areas.

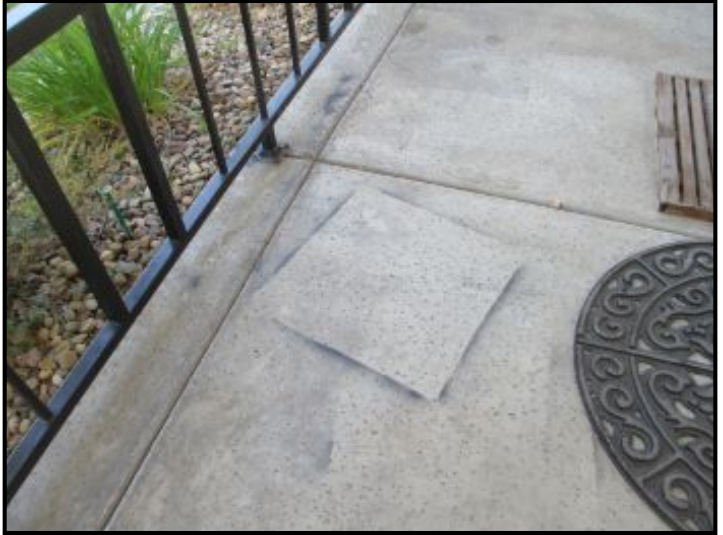
Concrete in front of bedroom 3

- Driveway and walkways in good condition. See picture of paint on concrete outside of bedroom 3 at front.

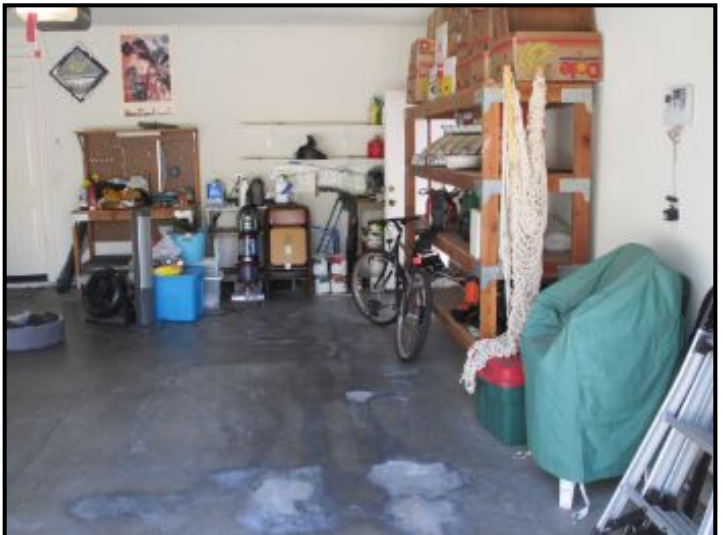
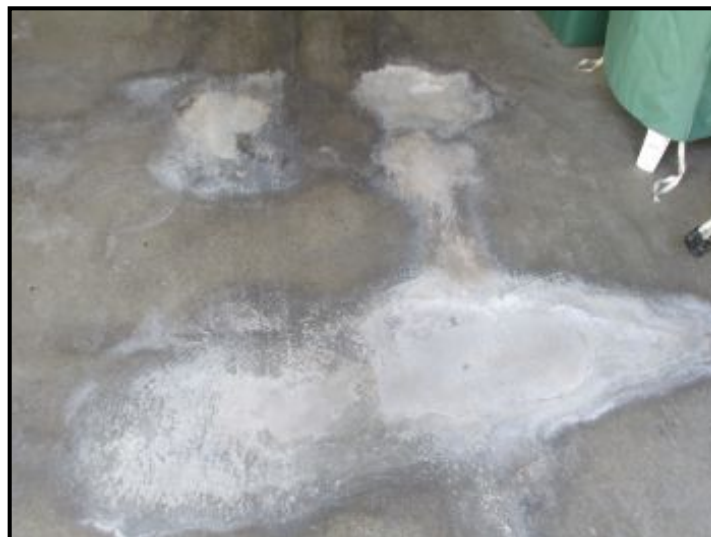
- Concrete slab has stains that appear to be from cleaning products used.

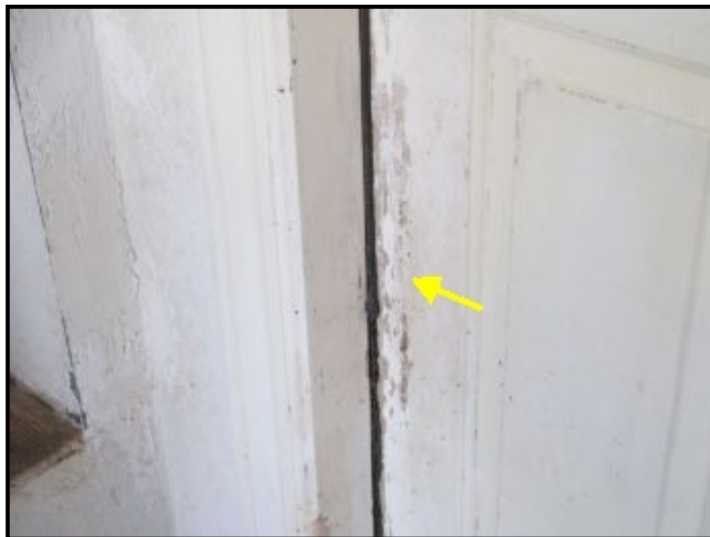
- Garage-house door weatherstrip: apparent pet damage. Also scratches on door, see photo

Door and weather strip damaged.

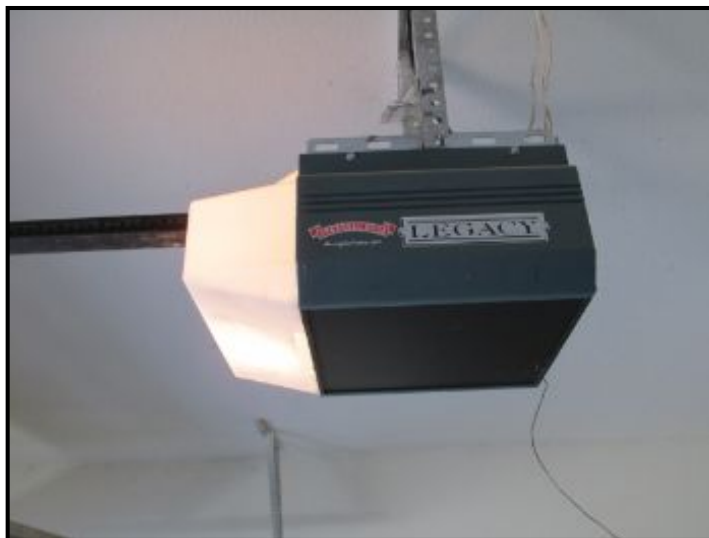
- Overhead door company legacy chain drive
- Has safety beam photo eye system for emergency reverse if beam is blocked.

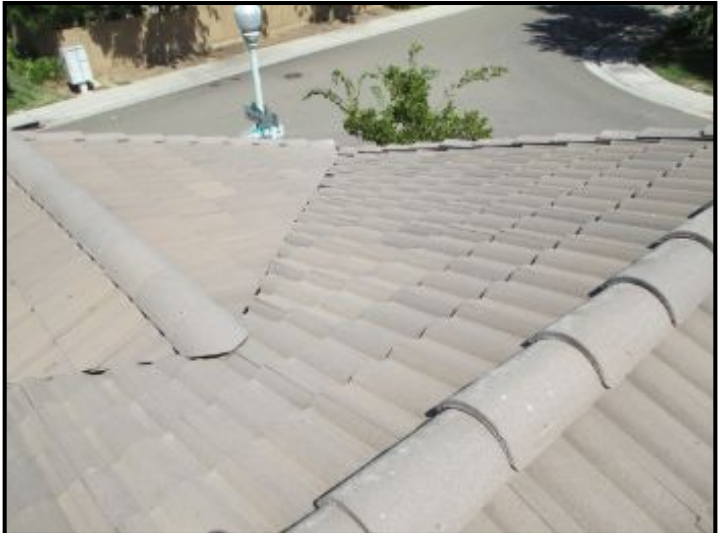
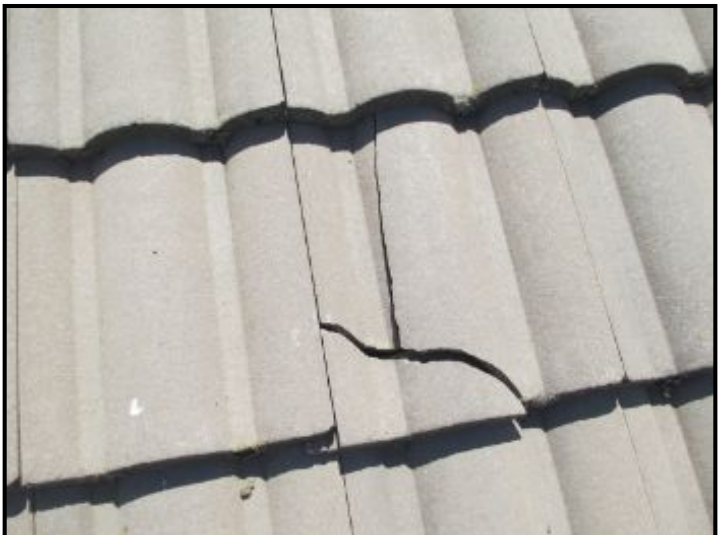
- (1) Broken tile, see photo. It can be repaired with roof adhesive caulking, or replaced.
- Location front left.
- "FYI"
- The roof is 11 years and appears to be in good serviceable condition.

area of broken tile

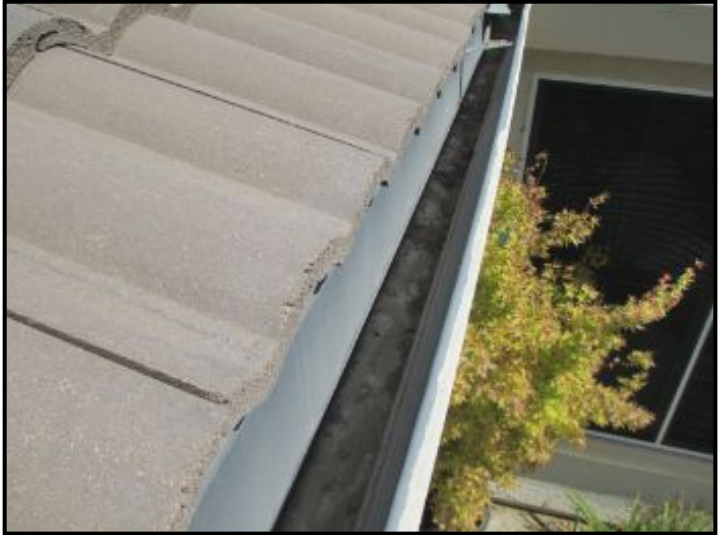
• Downspouts leading onto underground drainage piping has been used. The testing of underground drainage systems is beyond the scope of this inspection. Please ask owner about condition or perform your own testing before the close of escrow. It is further recommended that any underground drainage system be flushed at least once a year.

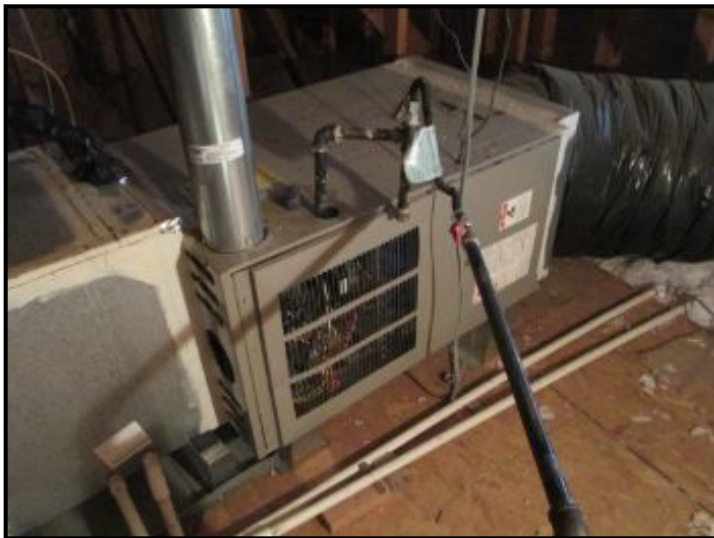
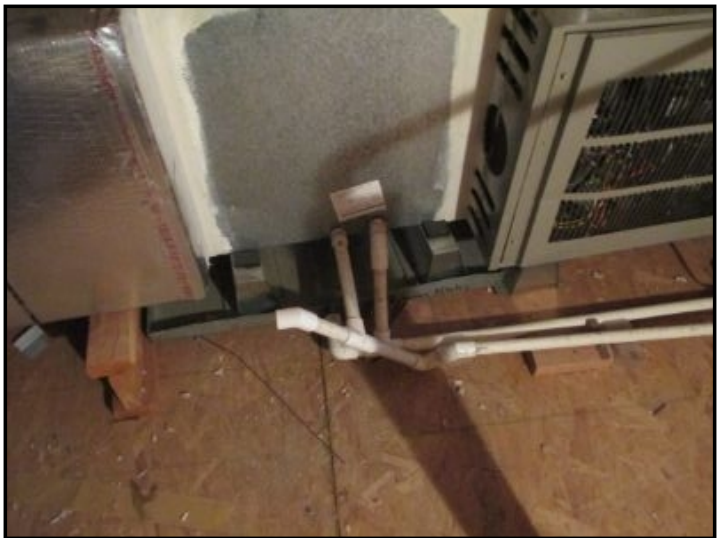
Location: • The furnace is located in the attic
Description:
 • Goodman serial # 0103615381, manufactured in 2001.
Observations:
 • The unit functioned properly using the normal controls (thermostat) and is 11 years old. These units generally last 15 - 20 years although some last longer.

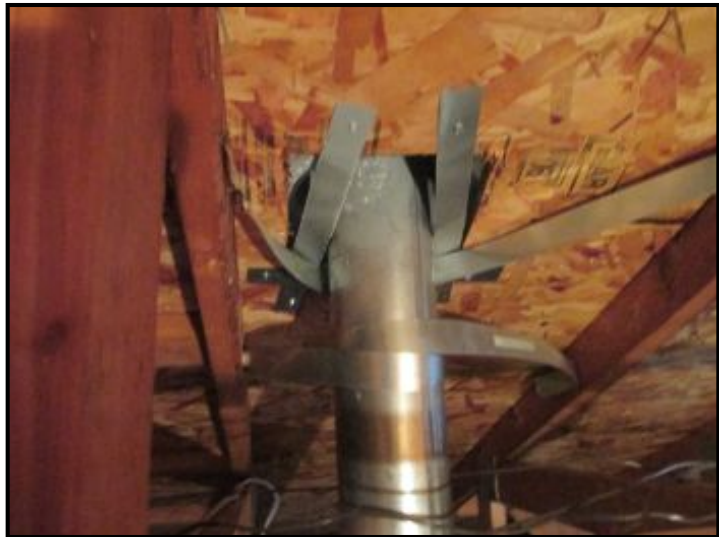
- Minimum furnace/water heater double wall vent pipe clearance from combustibile material is 1".

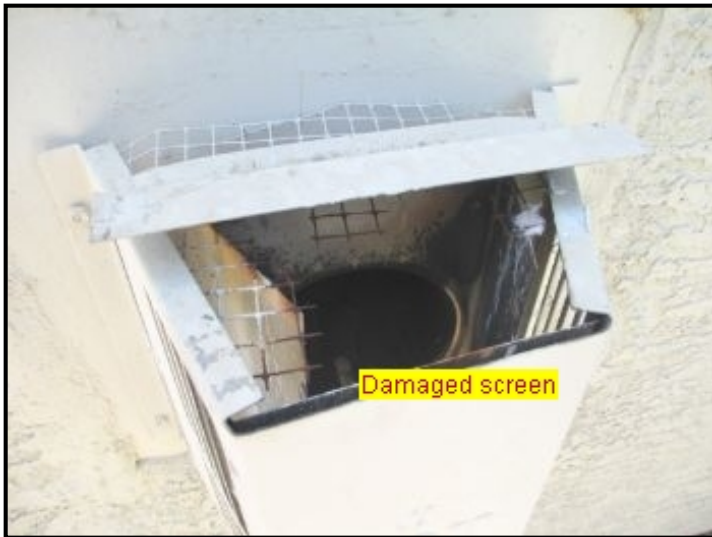
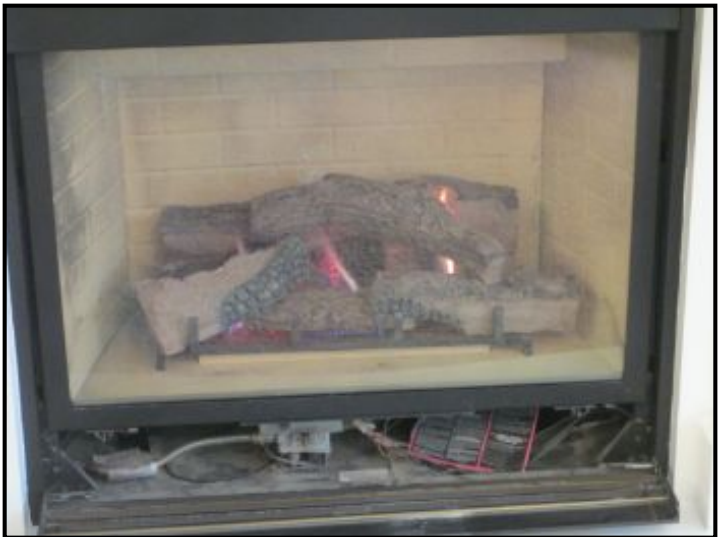
- Unit functioned correctly using normal; controls.
- "REPAIR AS NEEDED"
- Repair the screen at the direct vent located directly behind the fireplace at the exterior. This will keep birds and other vermin out of the duct.

Exterior direct vent

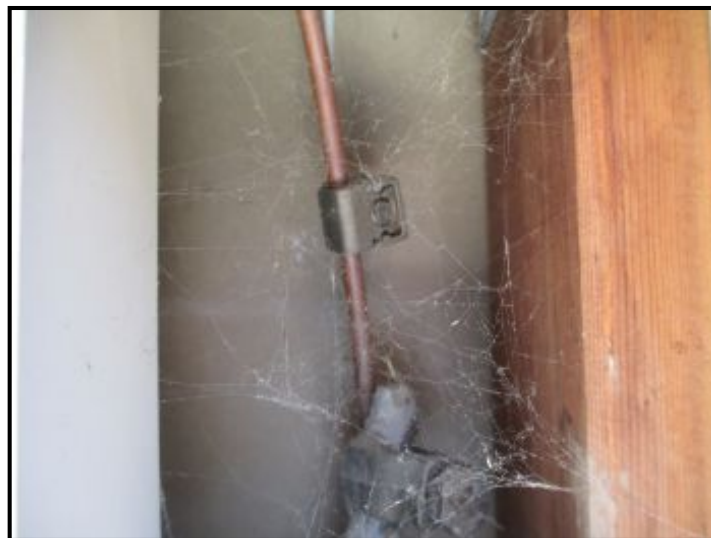
- Concrete enclosed electrode(Upher Ground). No major safety or function concerns at this time on visible portions.

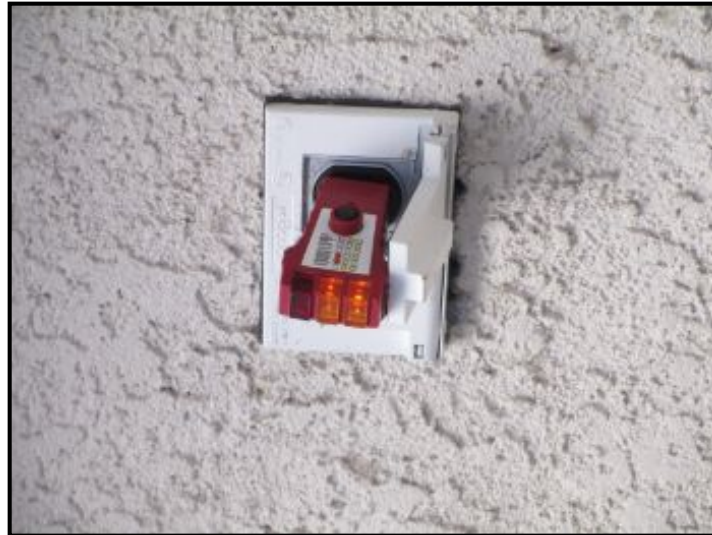
- All exterior lighting functional at time of inspection.
- GFCI in place and operational
- Reset for the GFCI outlets are in the:
 - Garage.
- Definition: Ground Fault Circuit Interrupter - GFCI - is an electrical safety device that cuts power to an individual outlet and/or entire circuit when as little as .005 amps is detected leaking--this is faster than a person's nervous system can react! Kitchens, bathrooms, whirlpools/hot-tubs, unfinished basements, garages, and exterior circuits are normally GFCI protected. This protection is from electrical shock.

Christmas light outlet under porch

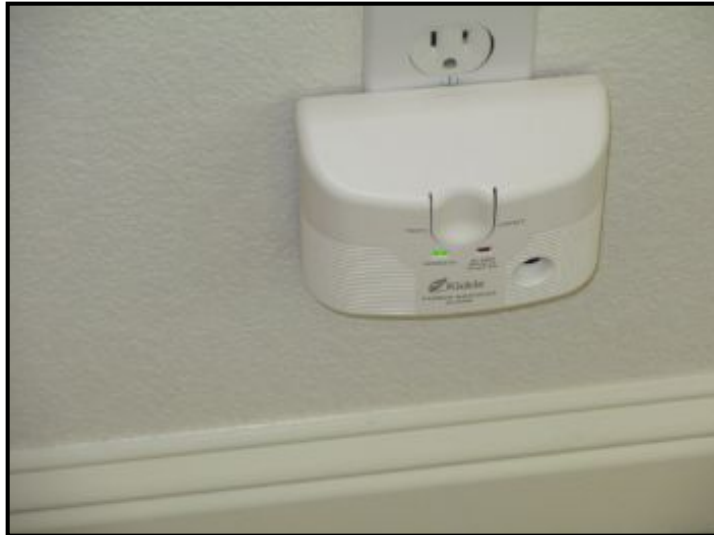
- Plug in Carbon Monoxide detectors installed.
- Move C/O detector from family room to the hallway near master bedroom.

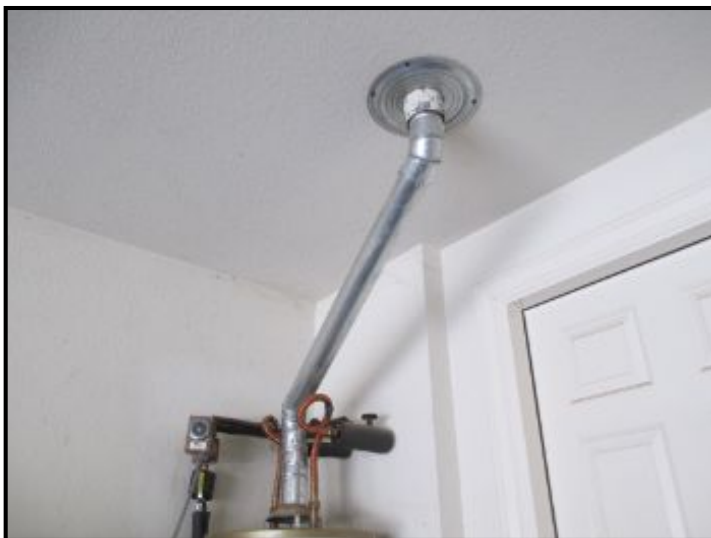
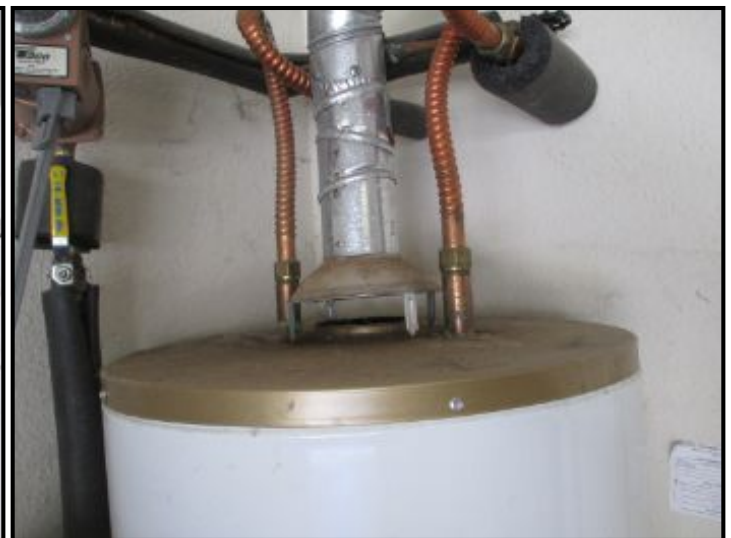
- Base, TPRV (Tank Pressure Release Valve), Strapping and Vent Inspected, no discrepancies.

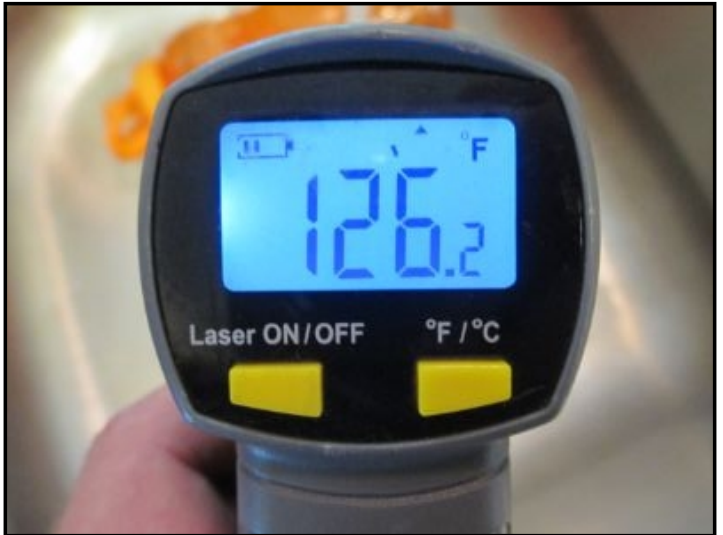
- The water heater is working as intended. It is 05 years old, the normal life expectancy is 12 - 15 years although some last longer. No discrepancies noted.
- Water temperature observed to be: 126 degree F. This is too hot Recommended temp should be set at 118-122 degrees F . Over 122 degrees can scald young children. Keeping it at or below 122 degrees can extend water heater life, and improve energy efficiency and conservation. "Recommend adjusting to lower temperature."
- Taco circulator pump and timer installed. Recommend asking seller for operating instructions or downloading them off of the internet.

Taco water circulator and timer

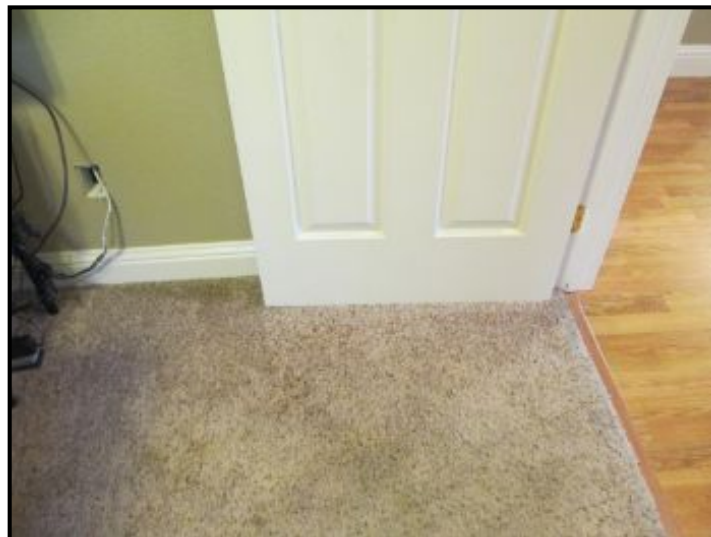
Observations:
 • Bed 4
 • The bedroom door needs to be cut down as it drags on the carpet. Normal clearance is 1/2" to 3/4" off of flooring.

Bedroom 4 door drags

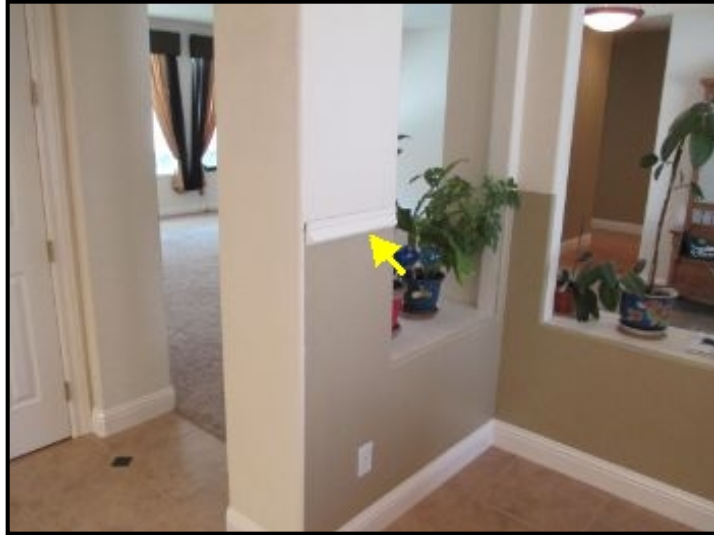
Observations:
 • "Inspected no major concerns, some visible patches."
 • "FYI"
 • See photo of loose trim at nook.

Loose trim

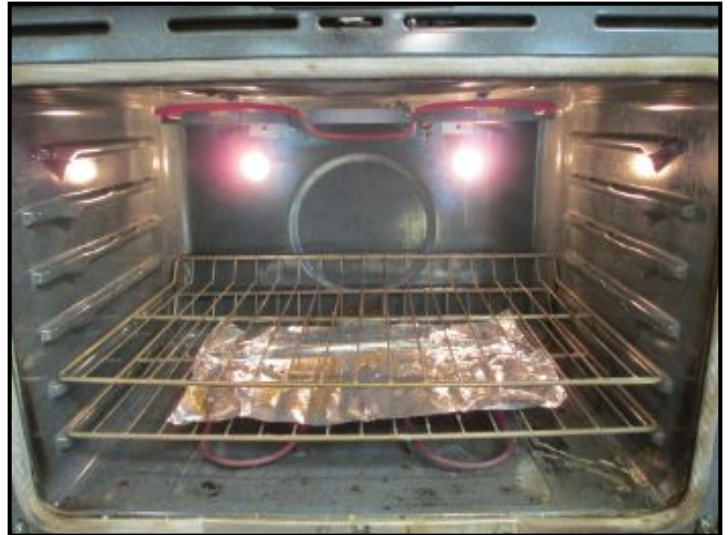
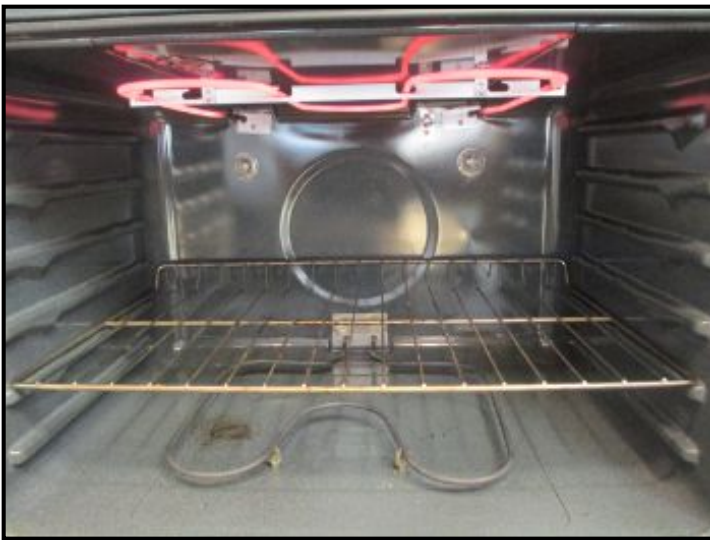
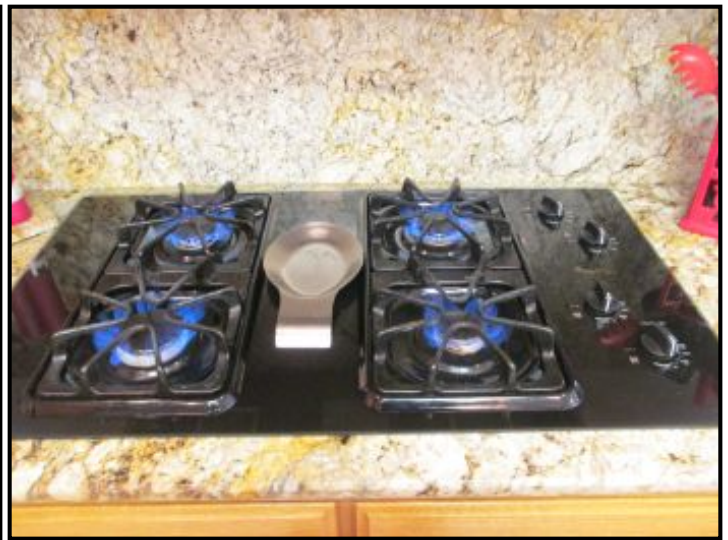
- The upper and lower electric ovens were tested at the time of inspection and appeared to function properly. I heated them both to 350 degrees F. The testing of temperature accuracy or timer functions are beyond the scope of this inspection.
- Cooktop in good serviceable condition.

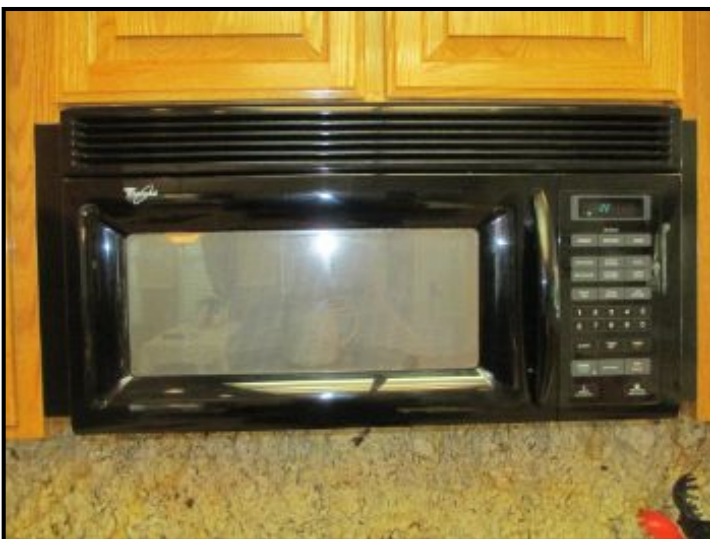
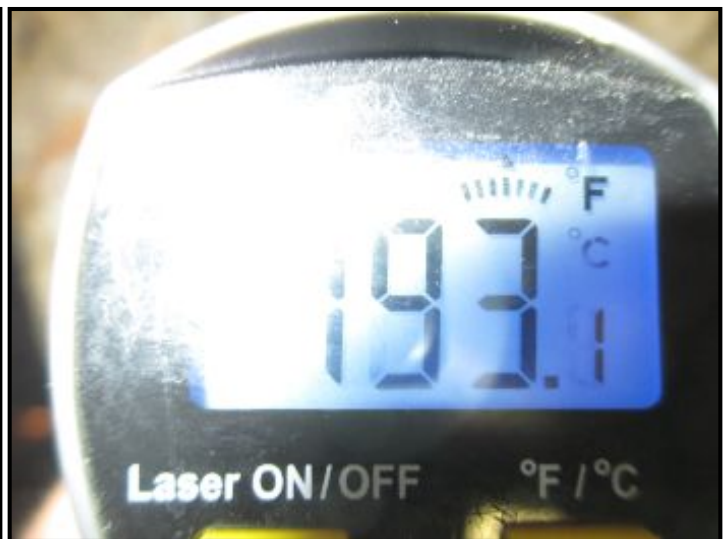
- Whirlpool microwave.
- The microwave heated 6 oz of water to 193 degrees F. in 2 minutes. (Good)

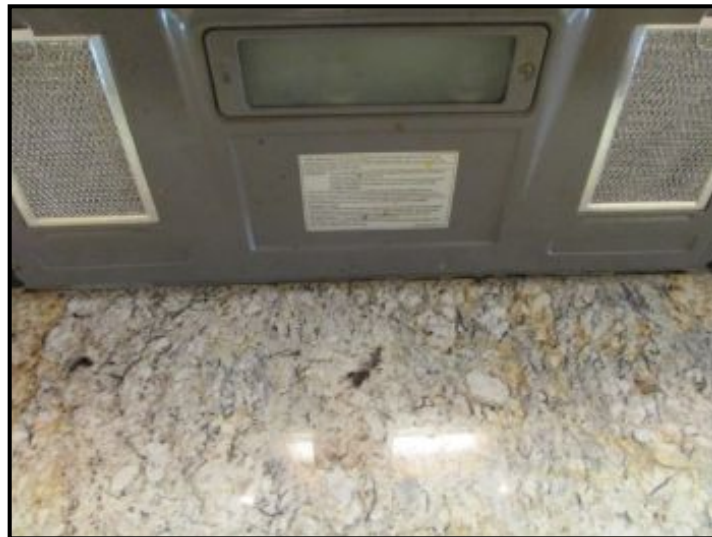
- Exhaust fan and surface lights working, recommend cleaning filters now and on a regular basis.

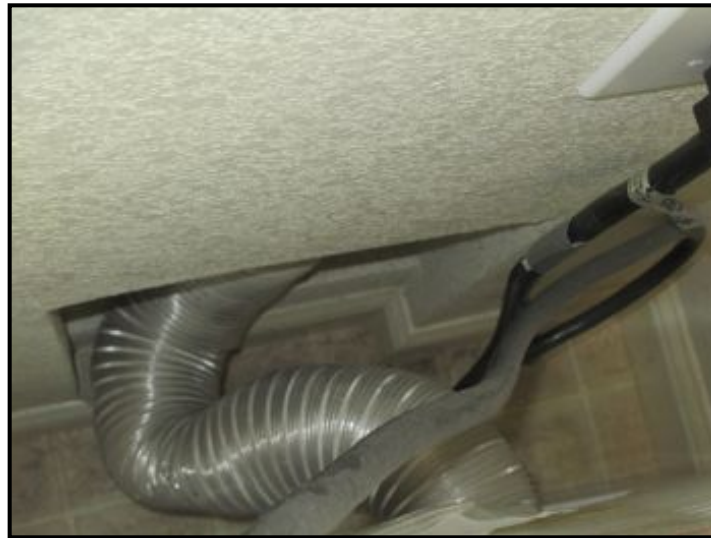
- It is currently hooked up to a dryer and functional.
- Recommend cleaning dryer vent before use. "Maintenance"

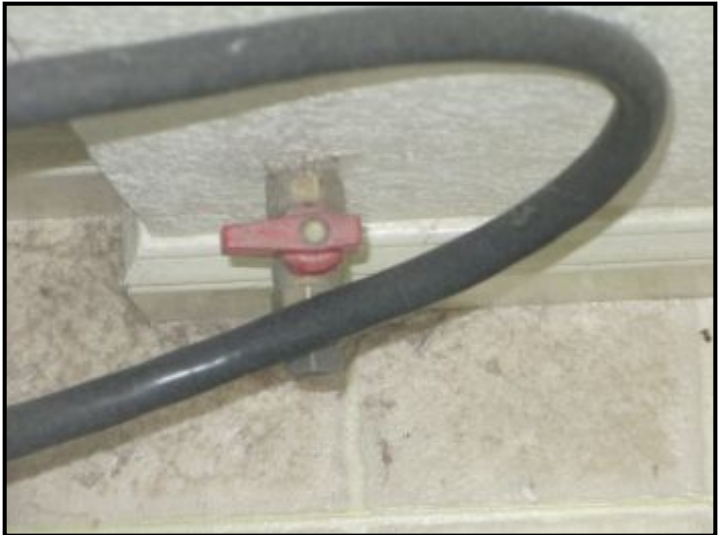
- Gas line or 240 volt 4 prong plug available for dryer.
- gas line capped

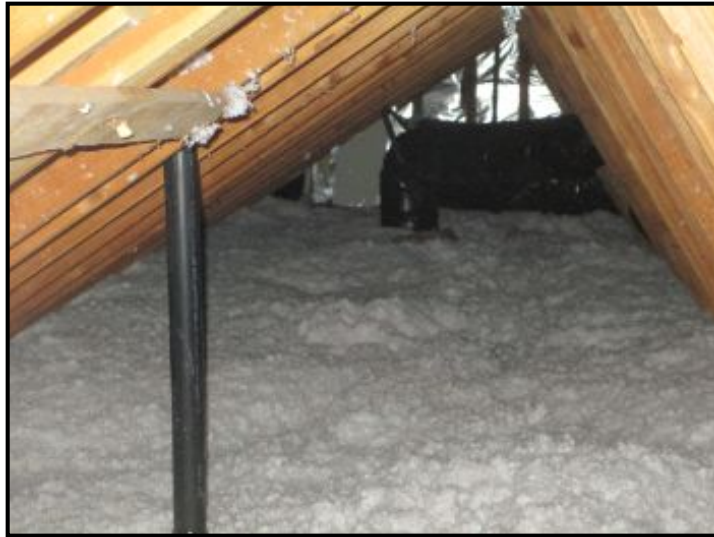
Materials:
 • Blown in cellulose insulation noted.
 Depth: Insulation averages about 12-14 inches in depth
 Observations:
 • The Department of Energy R-Value recommendation for attic insulation in the central california area U.S. is R-30. This house is at or exceeds this standard.

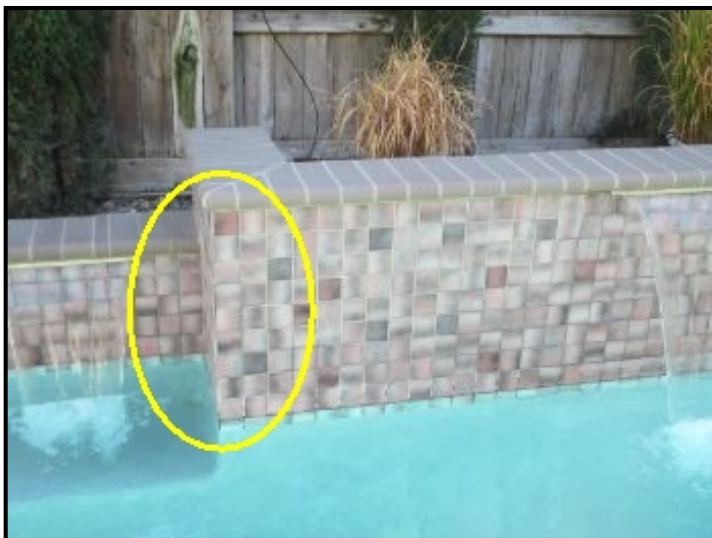
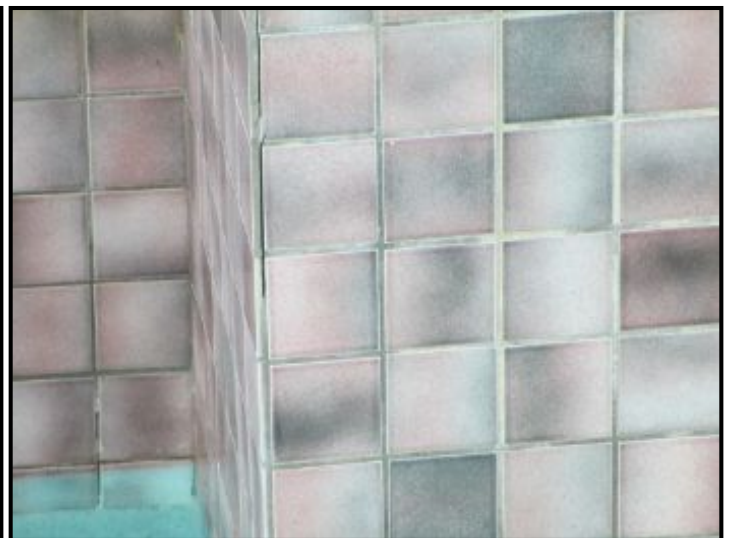
- loose tiles at the left of the main water fall see photo. repair as needed.
