# *Acutec Home Inspection*

## Property Inspection Report

Sample ave, Sacramento CA, 95888  
Inspection prepared for: Sample Sample  
Agent: sample sample -

Inspection Date: 10/27/2011 Time: 11:00 am  
Age: 54 years built 1957 Size: 2233 Sqft.  
Weather: Clear

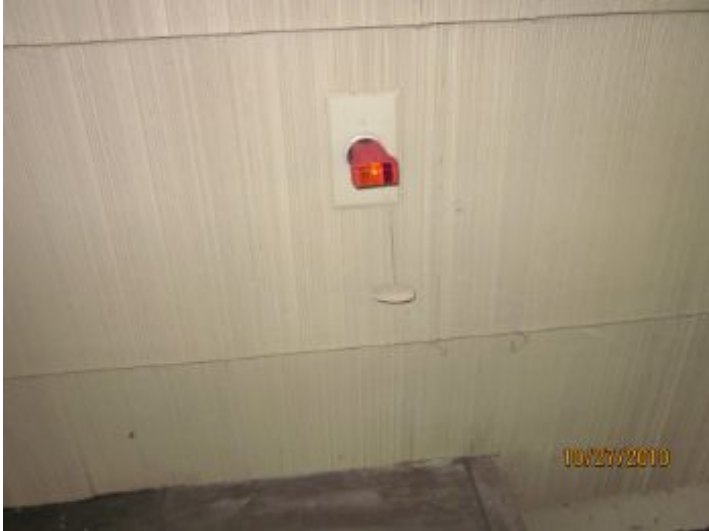
At patio

• *Outside outlets have an open ground and are not GFCI protected. GFCI outlets have been required since 1973 on outdoor outlets. Consider upgrading to the current safety standards of GFCI protection.*

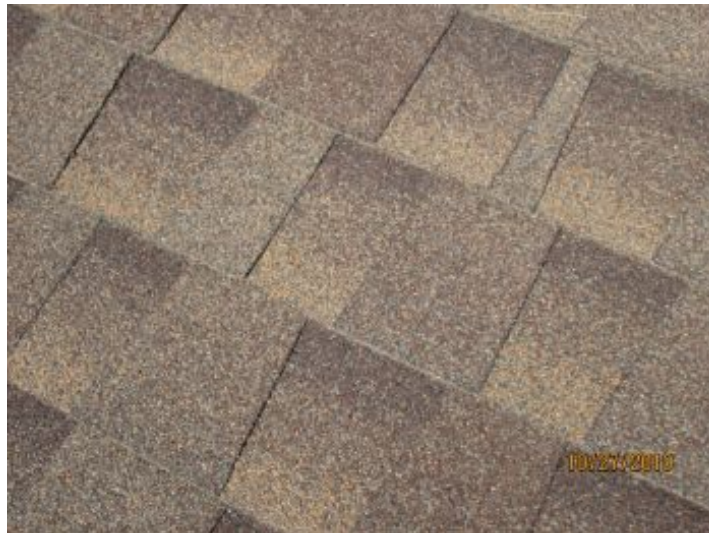
- *[Inspected]*
- *Clean debris out of valleys and around skylite.*
- *Appears to be in good condition.*

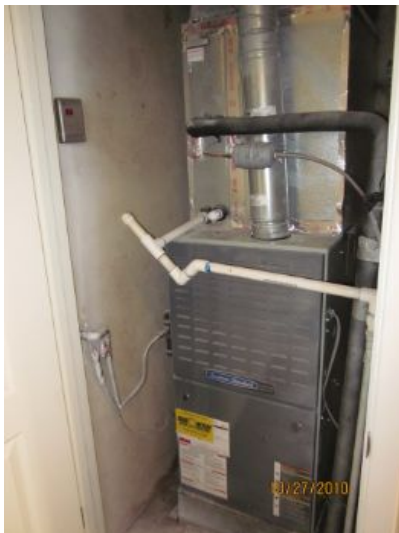
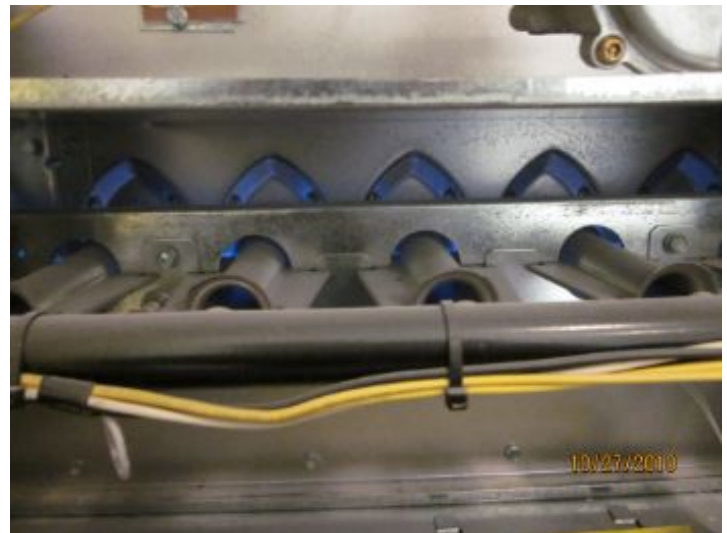
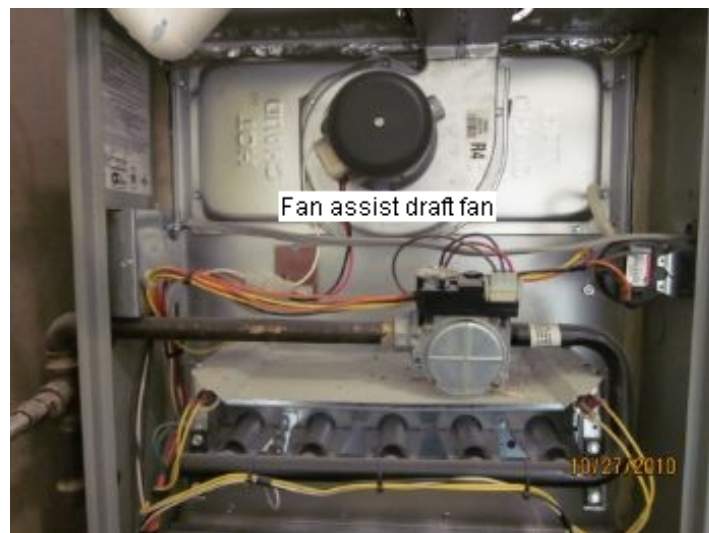
- The system is 4 - 5 years old. It is functioning fine at this time. The heat differential was 40 - 45 degrees. (difference from return air to air out at registers).

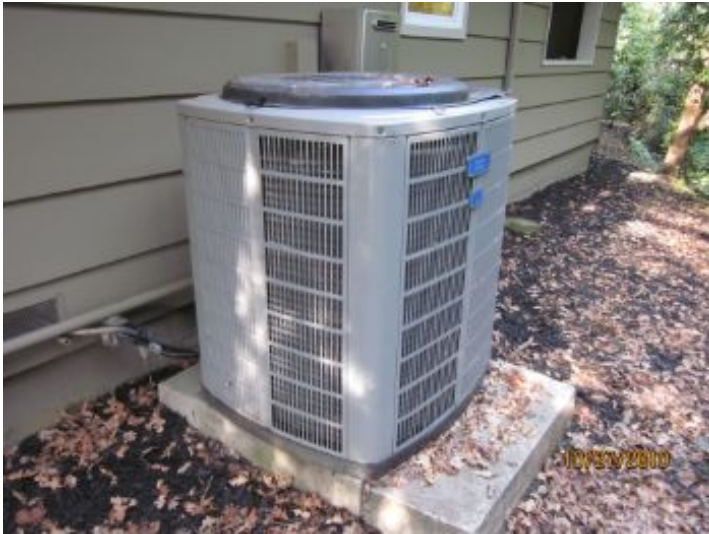
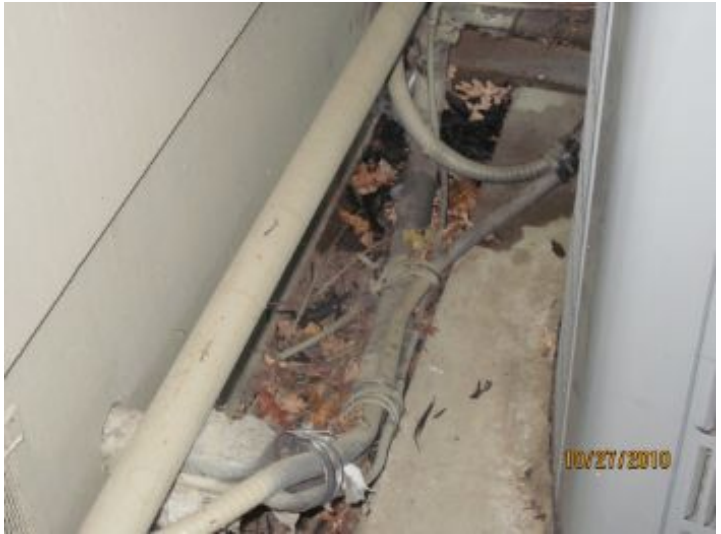
Line set

- 4 - 5 years old working well at time of inspection.
- Cooling differential was 25 - 29 degrees well within guidelines.

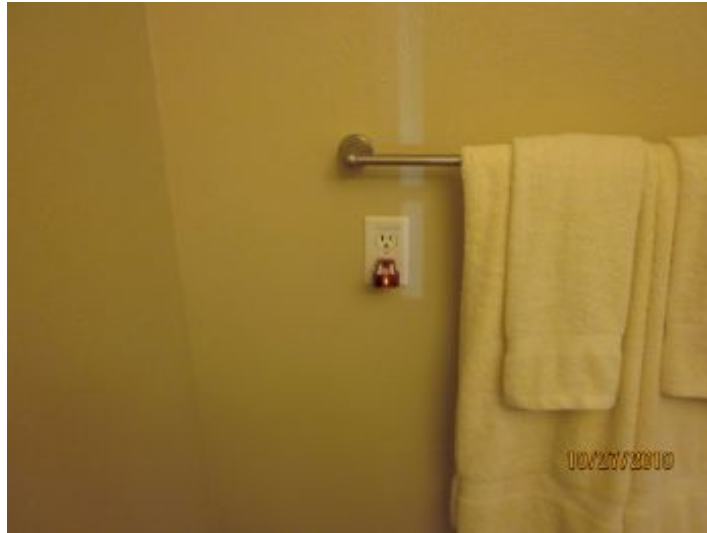
- *Outlet in bath 2 is marked GFCI protected, open ground. Same situation as mentioned under interior rooms outlets GFI protected no ground. See Interior section fans/lights/outlets for a complete description.*

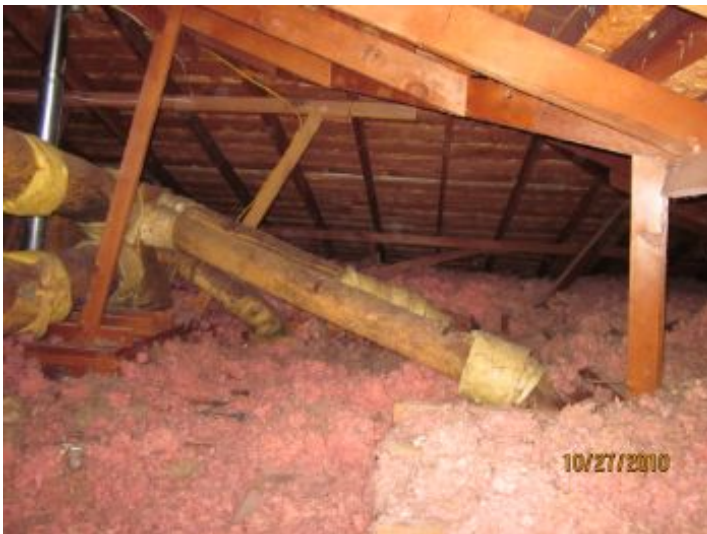
- *You may benefit from upgrading the attic insulation.*

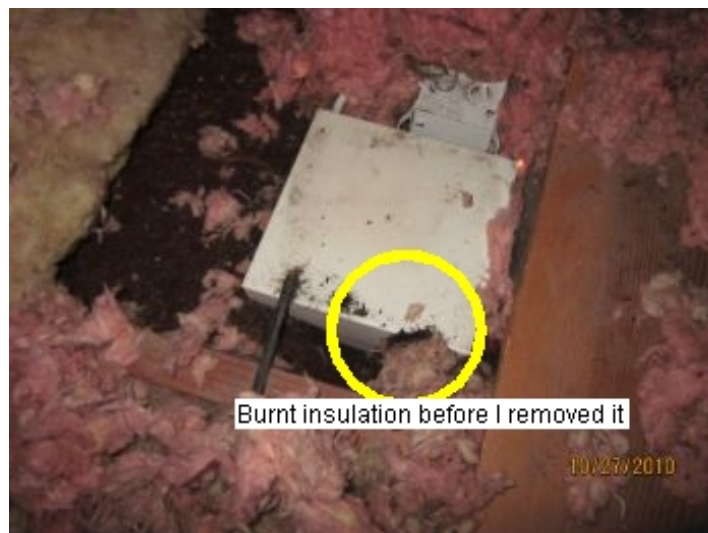
Fire danger

- *3 ea can lights at entry and hallway are not rated for direct contact with insulation. I located 2 and partially removed the insulation around them. Clear the insulation around these lights at least 6" to prevent fire [Safety]*

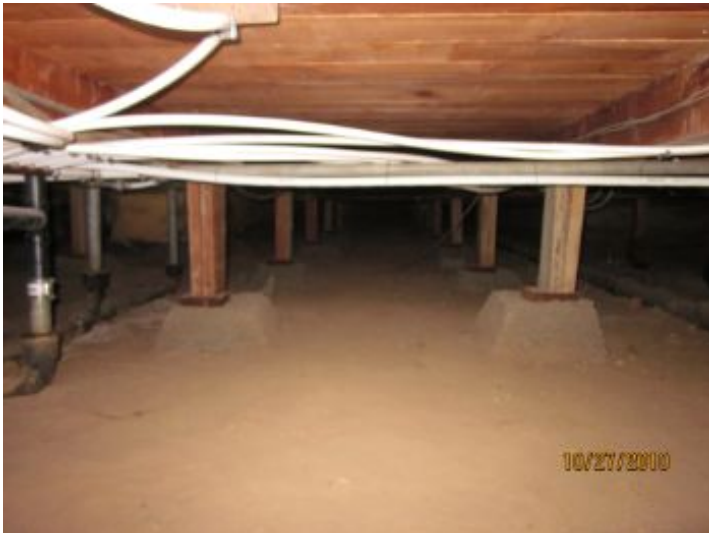
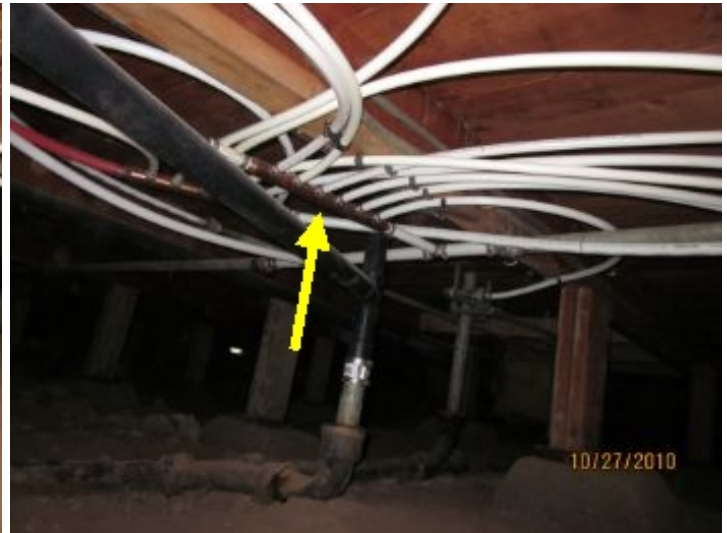
Manifold for Pex piping

- Pex piping has been installed and ran approximately half way to where it has been attached to original galvanized piping. It appears that the pex only runs fully to bath 2.
- Drain pipe leak in crawl space under kitchen. Very slow drip at iron pipe joint see photos. [Repair as needed]

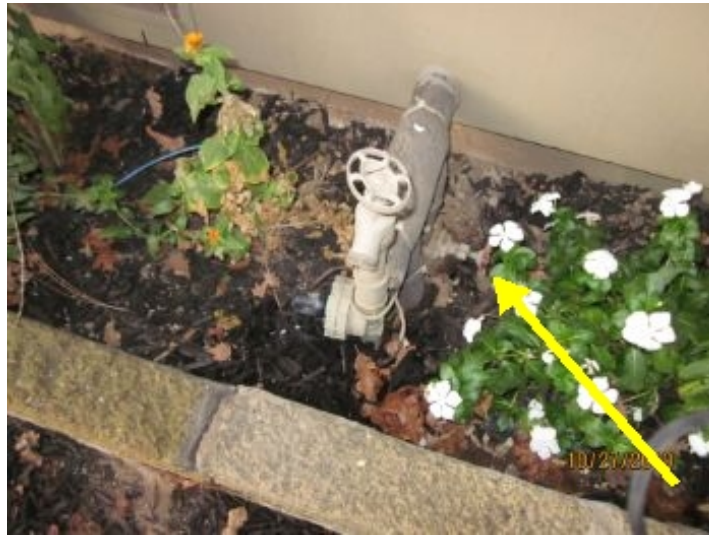
At right front

Location: Front right of walkway

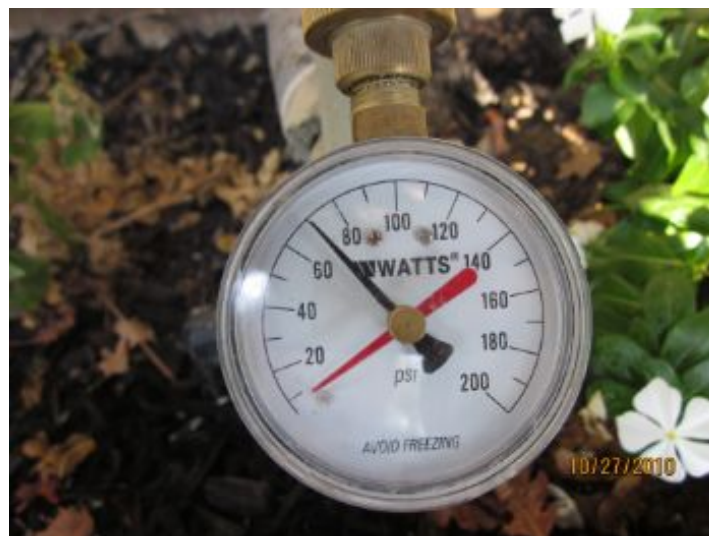
- 70 psi (good)
